Existing Facility Evaluation

The Winnebago County Public Safety Center is located at 216 South Clark Street in Forest City, Iowa. The building was originally the Forest City Municipal Hospital and was built in 1924. The original structure is a two story double wall masonry building with a basement. The foundation is formed concrete walls. The building is approximately 2,800 square foot per floor. The main heating is provided by a boiler installed in 1987 and radiant heat is provided by radiators. The roof top units provide the air conditioning and are over 20 years old. The roofing is a Firestone EPDM roofing system that is approximately 15 years old which appears to be in fair condition but has been patched several times. An elevator was installed with the original building.

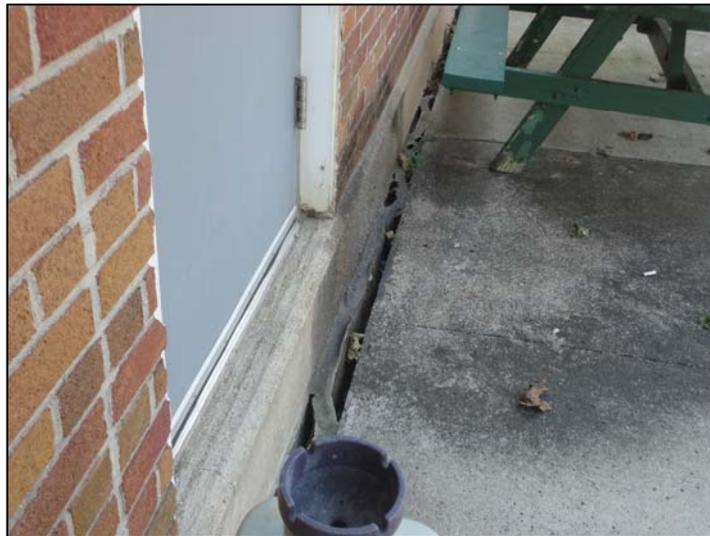
The masonry brick on the building has been tuck pointed several times. Minimum additional tuck pointing is required. The foundations have separated from the sidewalks and leaking in several areas has been experienced. Removal of the sidewalks, waterproofing of the foundation walls and replacement of the sidewalks would assist in minimizing leaking through the foundation. The insulation of the exterior walls would be minimal with the double wall masonry construction and insulating the building could only be accomplished by furring out the exterior walls.

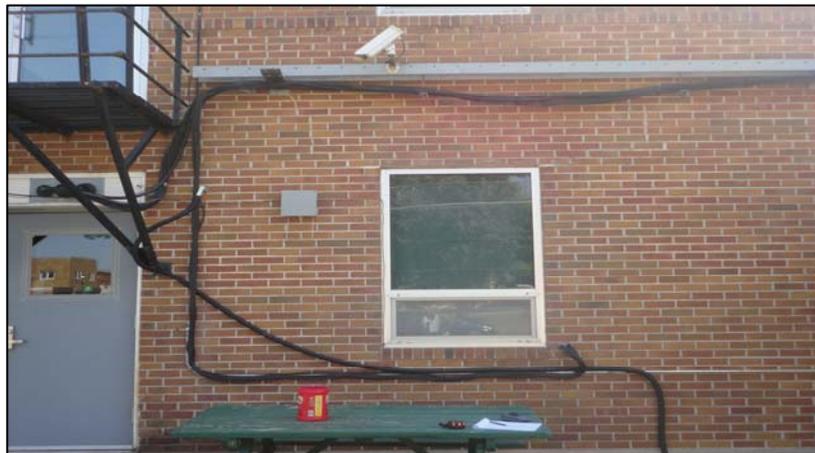
Modifications were required to convert the building from the hospital to the Sheriff's Office, Jail and E-911. The double wall masonry construction required all utilities and lines to be mounted to the exterior of the building. The interior walls that are hardened walls many which are block with plaster require wiring to be surface mounted throughout the facility.

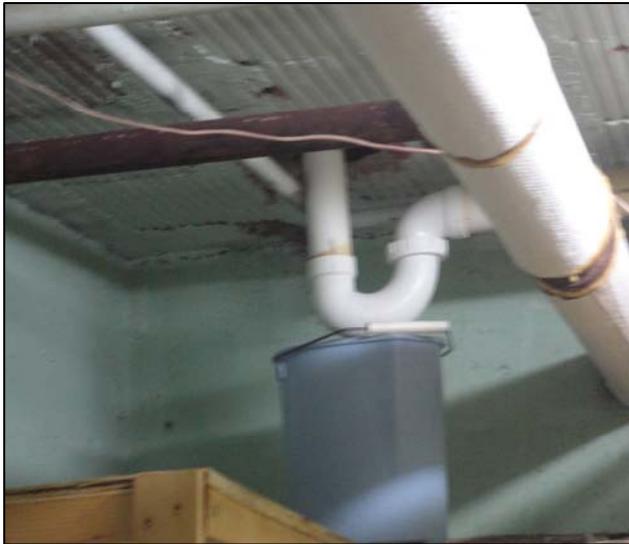
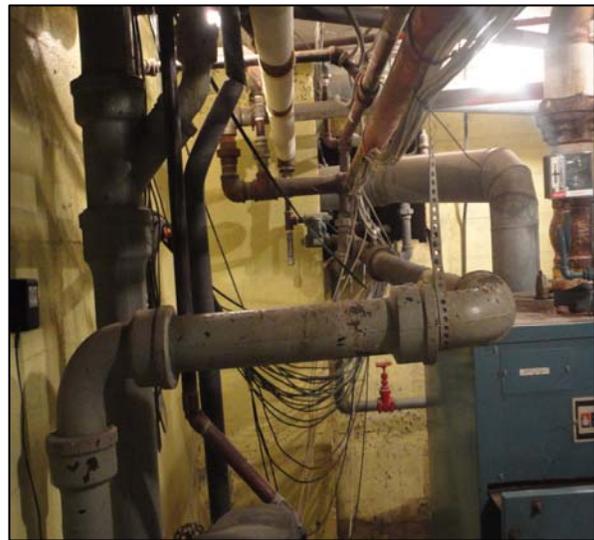
The plumbing in general is in need of constant repair. As discussed previously, this would include the water heating plumbing. A majority of the plumbing is going through cast-in-place floors and hardened construction which will require demolition for proper replacement. Any renovation would need to include plumbing replacement to the extent possible.

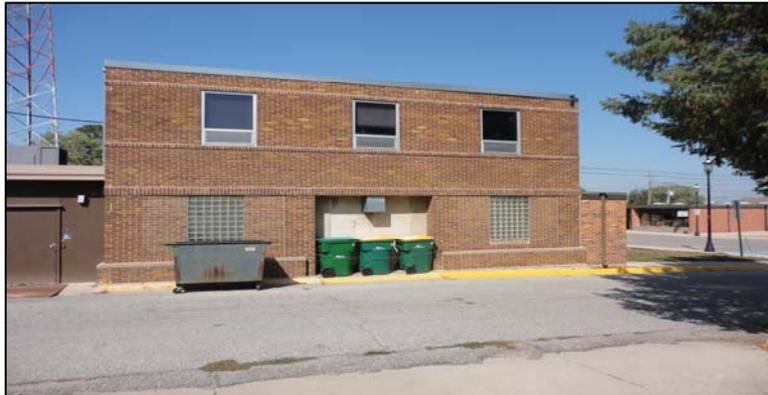
The windows and doors in the exterior envelope are of low insulation value and replacement should be considered. Windows in the jail or secure areas are of commercial quality and not attack resistant. These windows have required steel mesh on the inside of the windows to provide security. Many of the windows are still the block glass. A schedule for replacement of windows should be established to avoid a high onetime cost. Any renovation should take the window replacement into consideration to avoid damaging new finishes.

Replacement of the windows should reduce operational costs and grants for energy efficient programs or rebates should be researched.

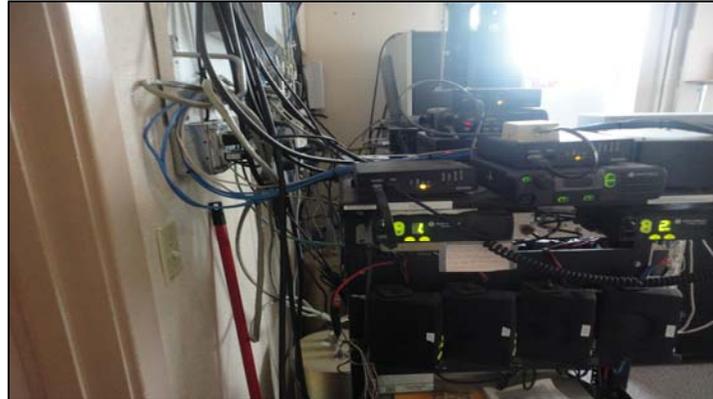
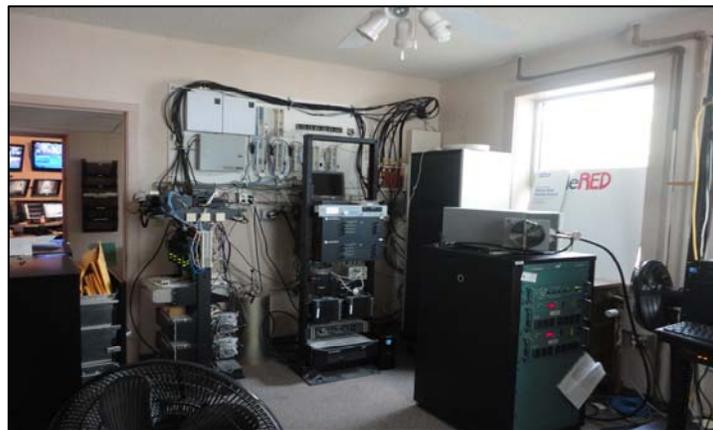
E-911 – Dispatch Equipment Room

The walls are hardened structures which limits any expansion capabilities. Lighting, cables, electrical outlets and conduits are required to be surface mounted because of the wall structure. This creates problems with efficiently mounting wiring. The radio equipment and telecommunications are typically located in the same equipment room. Due to lack of space the radio and telecommunication systems are located in the basement. The air conditioning is insufficient to keep up with the heat generated from the equipment. The windows in the room should be replaced with an energy efficient security type of window for protection from severe weather conditions and security.

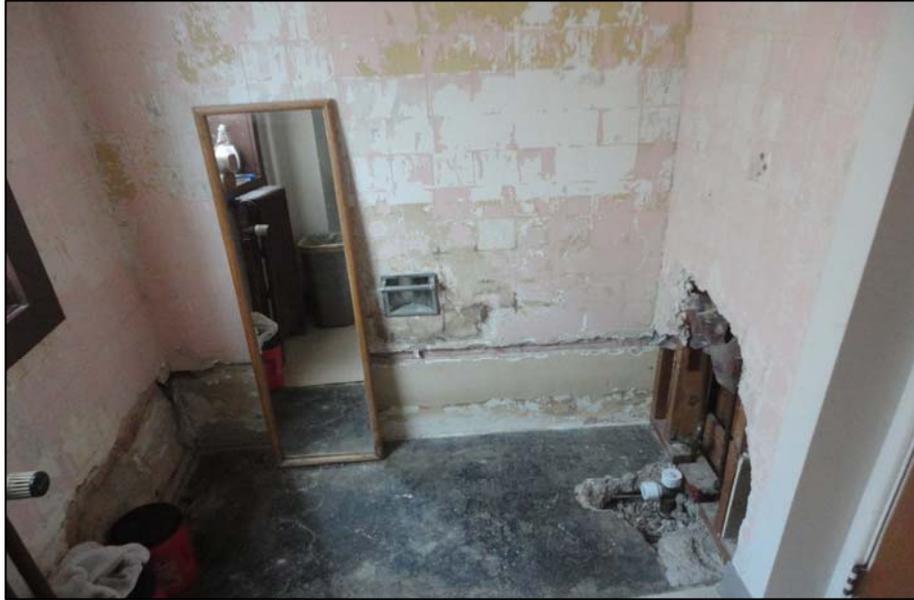
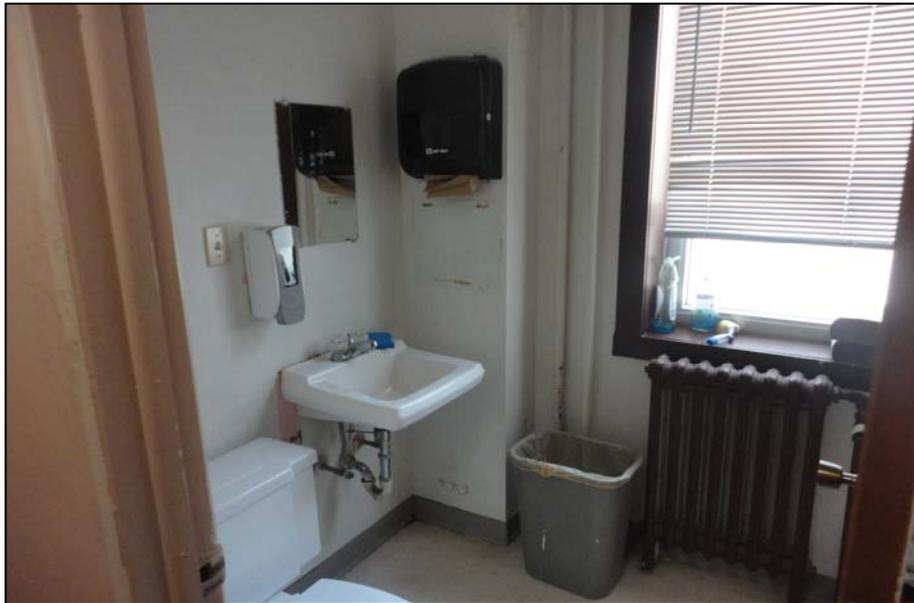
The walls are hardened structures which limits any expansion capabilities. Toilets and lavatories have been relocated throughout the area and walls and floors have not been repaired. The wall and ceiling plaster finishes are deteriorated with exposed plumbing and cabling. The size and entry through other areas do not meet ADA requirements for the staff or public. There is no exhaust from the restroom. Public response to the conditions of this room would be poor and due to the exposed paints and plasters should be repaired for the safety of employees and public.

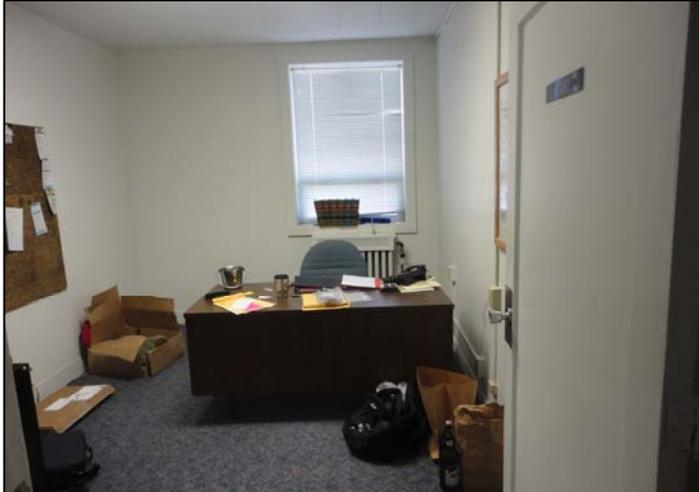
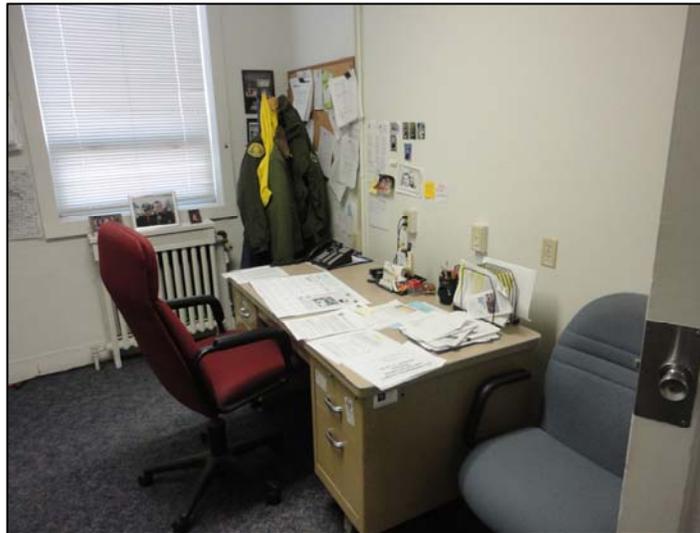
The offices are long and narrow which does not allow for a good furniture layout. The offices have surface mounted power and telephone but did not have any data outlets. Use of a computer would allow the deputies to utilize their offices more and complete their tasks more efficiently. The lighting is bad and needs replaced. Heat is provided through a radiator which the piping is showing signs of deterioration and water damage is visible at the floor. The walls are hardened structures which does not allow for simple renovation.

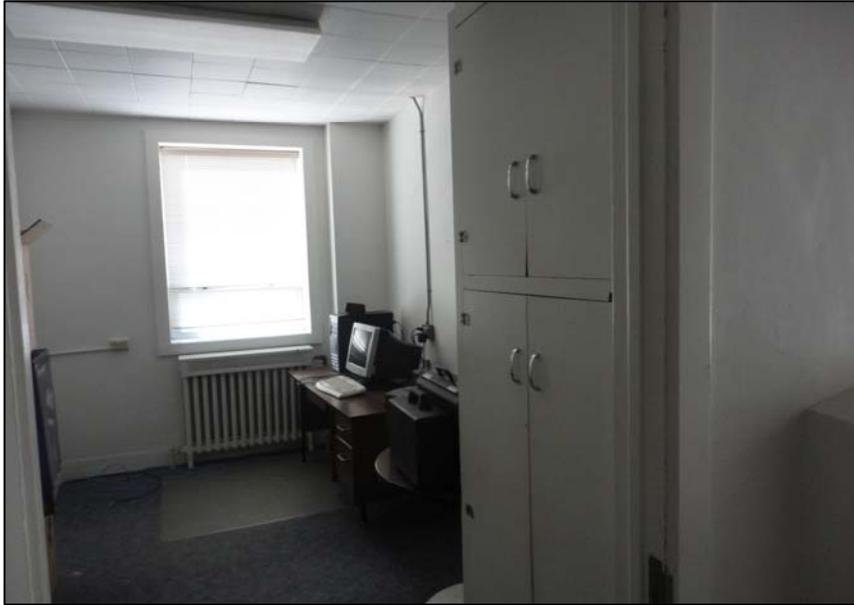
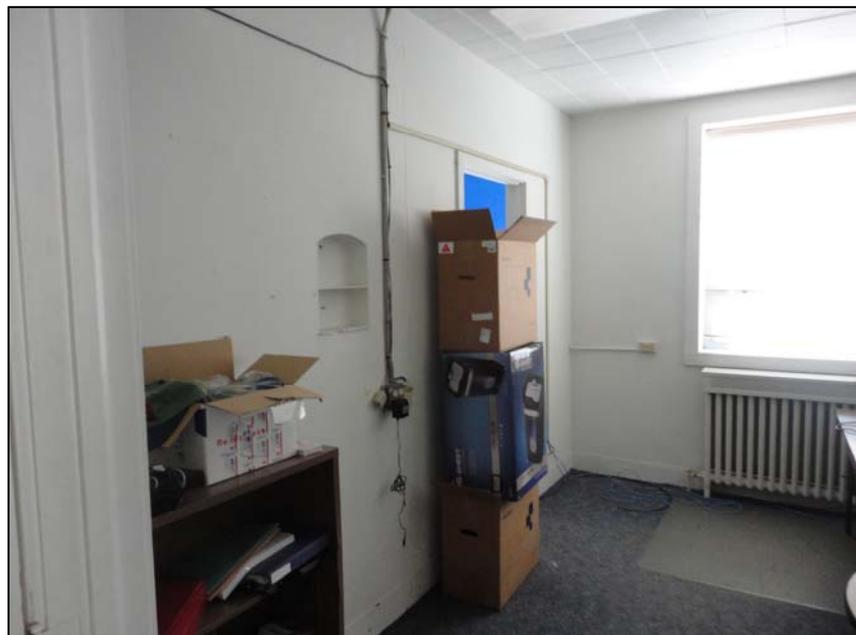
There are several surface mounted conduits which have been abandoned. All electrical is surface mounted and the light fixtures need to be replaced. This is one of the few rooms with data connections but does not have a phone connection. The cabinets take up space in the room which is on the verge of being too small for an office.

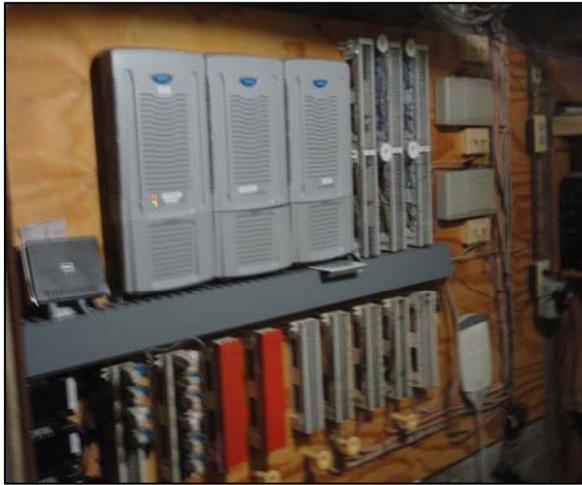
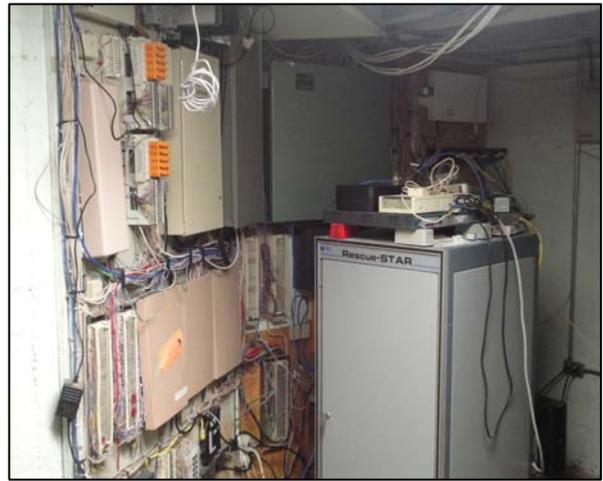
Additional power and data lines have been installed to accommodate the equipment. Lines have been run throughout the basement to the different first floor locations and to E-911 / Dispatch. The basement has experienced flooding over the years from the amount of piping, leaks through the foundation and major leaks from the elevator penthouse.

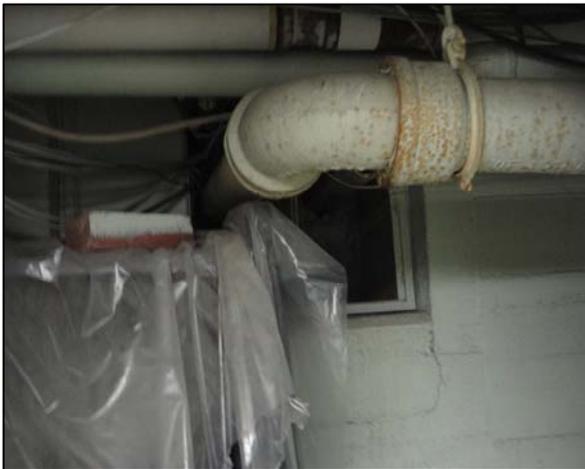
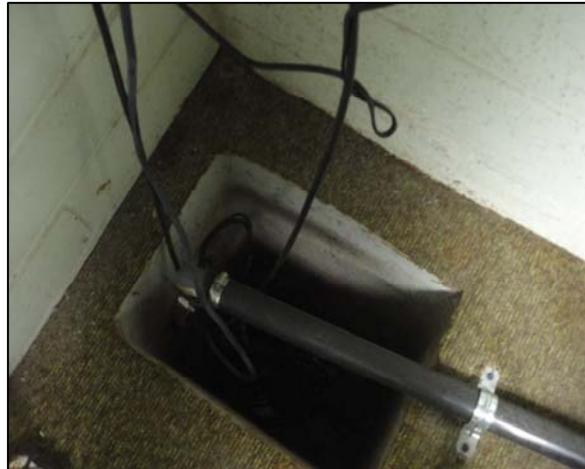
A sump pump has been installed in this room to avoid damage to the equipment due to water. This will help the risk of flooding if the sump is hooked to the emergency generator but would not function due to a power outage. If the flooding was severe enough the pump would not be able to keep up. There are pipes in the area that are deteriorating which creates a risk of possible damage to the equipment.

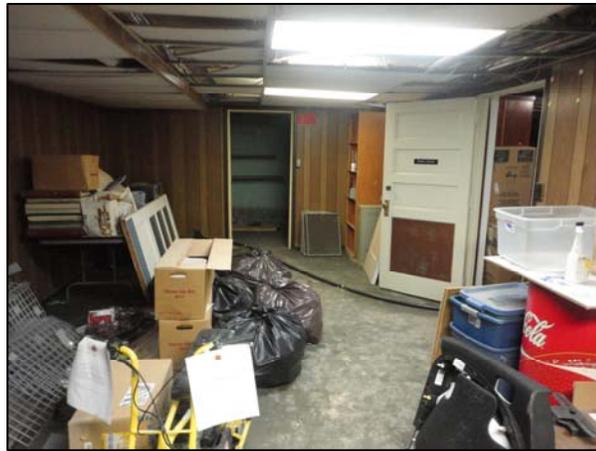
Due to the leaks and flooding, the items that can be stored in this area are limited. Ceilings are water damaged and mold can be observed. Panels have been removed to repair piping and to run cabling. Floor tiles are delaminating from the floor due to exposure to water.

It would be recommended that a professional firm specializing in removal of hazardous material be hired. All ceilings, paneling, shelving should be removed and disposed of legally. The firm should then clean up any hazardous materials including the delaminated floor tile.

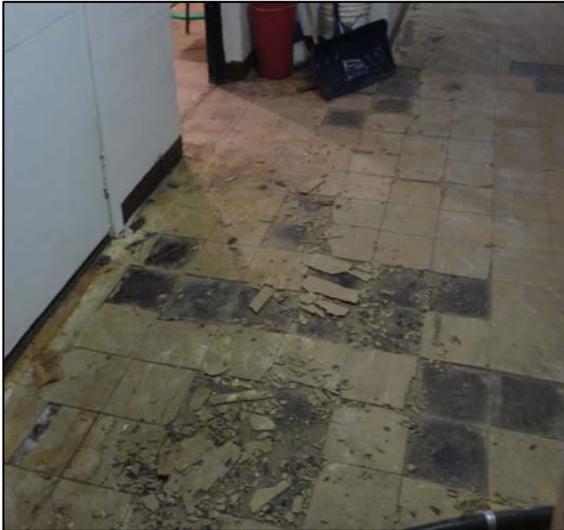
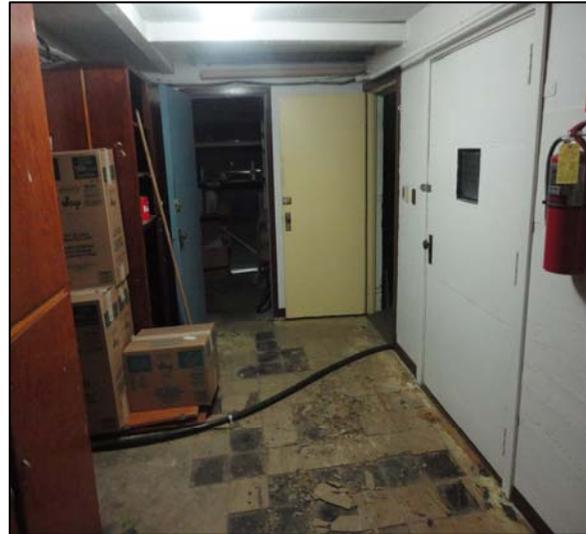
Basement Corridor

There are cabinets for storage but due to the high humidity levels not much can be stored. The floor tiles have delaminated from the floor due to water damage and high moisture. The tiles are breaking up and can create hazardous conditions with the air quality not only in the basement but to the staff, inmates and public. The hazardous material would stick to an individual's shoes and transported throughout the facility.

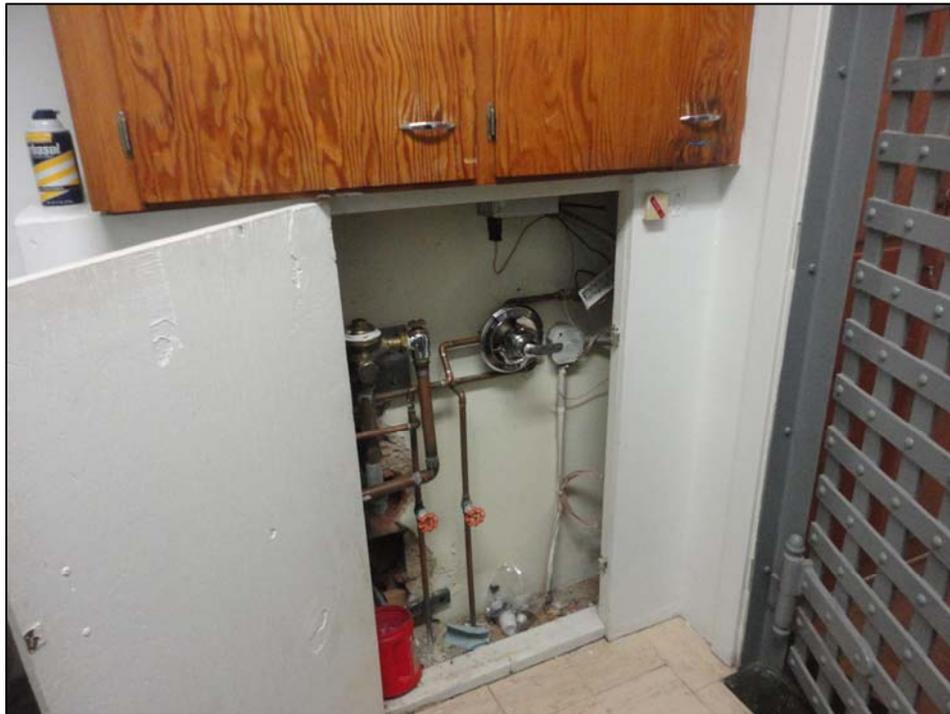
The heating is provided by radiant heat provided by radiators which have been enclosed in security grates. This type of heating is inefficient and maintaining consistent temperatures is difficult and costly. The shower and toilet is located directly off of the sleeping quarters and has minimum ventilation. The shower has to be manually turned on by staff in the corridor.

The plumbing has been repaired consistently and will require replacement sometime in the near future.

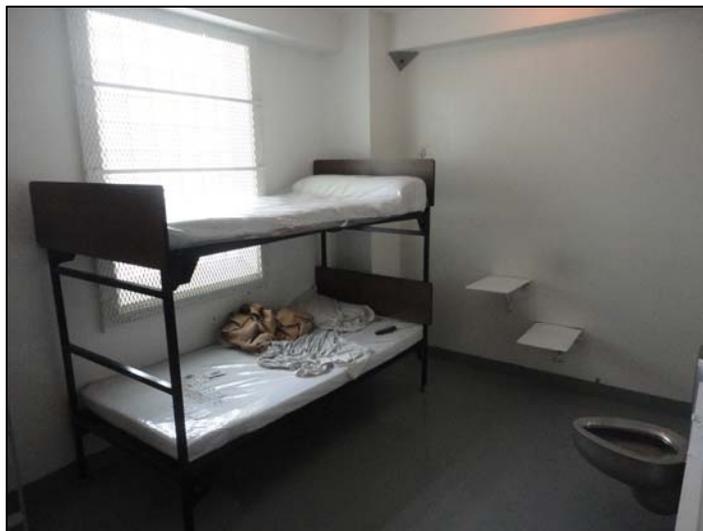
There is no shower available in this cell block. Females have to be moved to the detoxification cell and a temporary partition set up to allow the females to shower. The shower has to be turned on by the staff and the plumbing is located in the 1971 addition in the corridor. This becomes staff intensive for turning the water on and off to the shower.
