## **ENGINEER'S REPORT**

# **JOINT DRAINAGE DISTRICT NO. 35-89 LATERAL 12 WATERWAY WINNEBAGO & KOSSUTH COUNTY, IOWA**

**PROJECT NO: E26056**

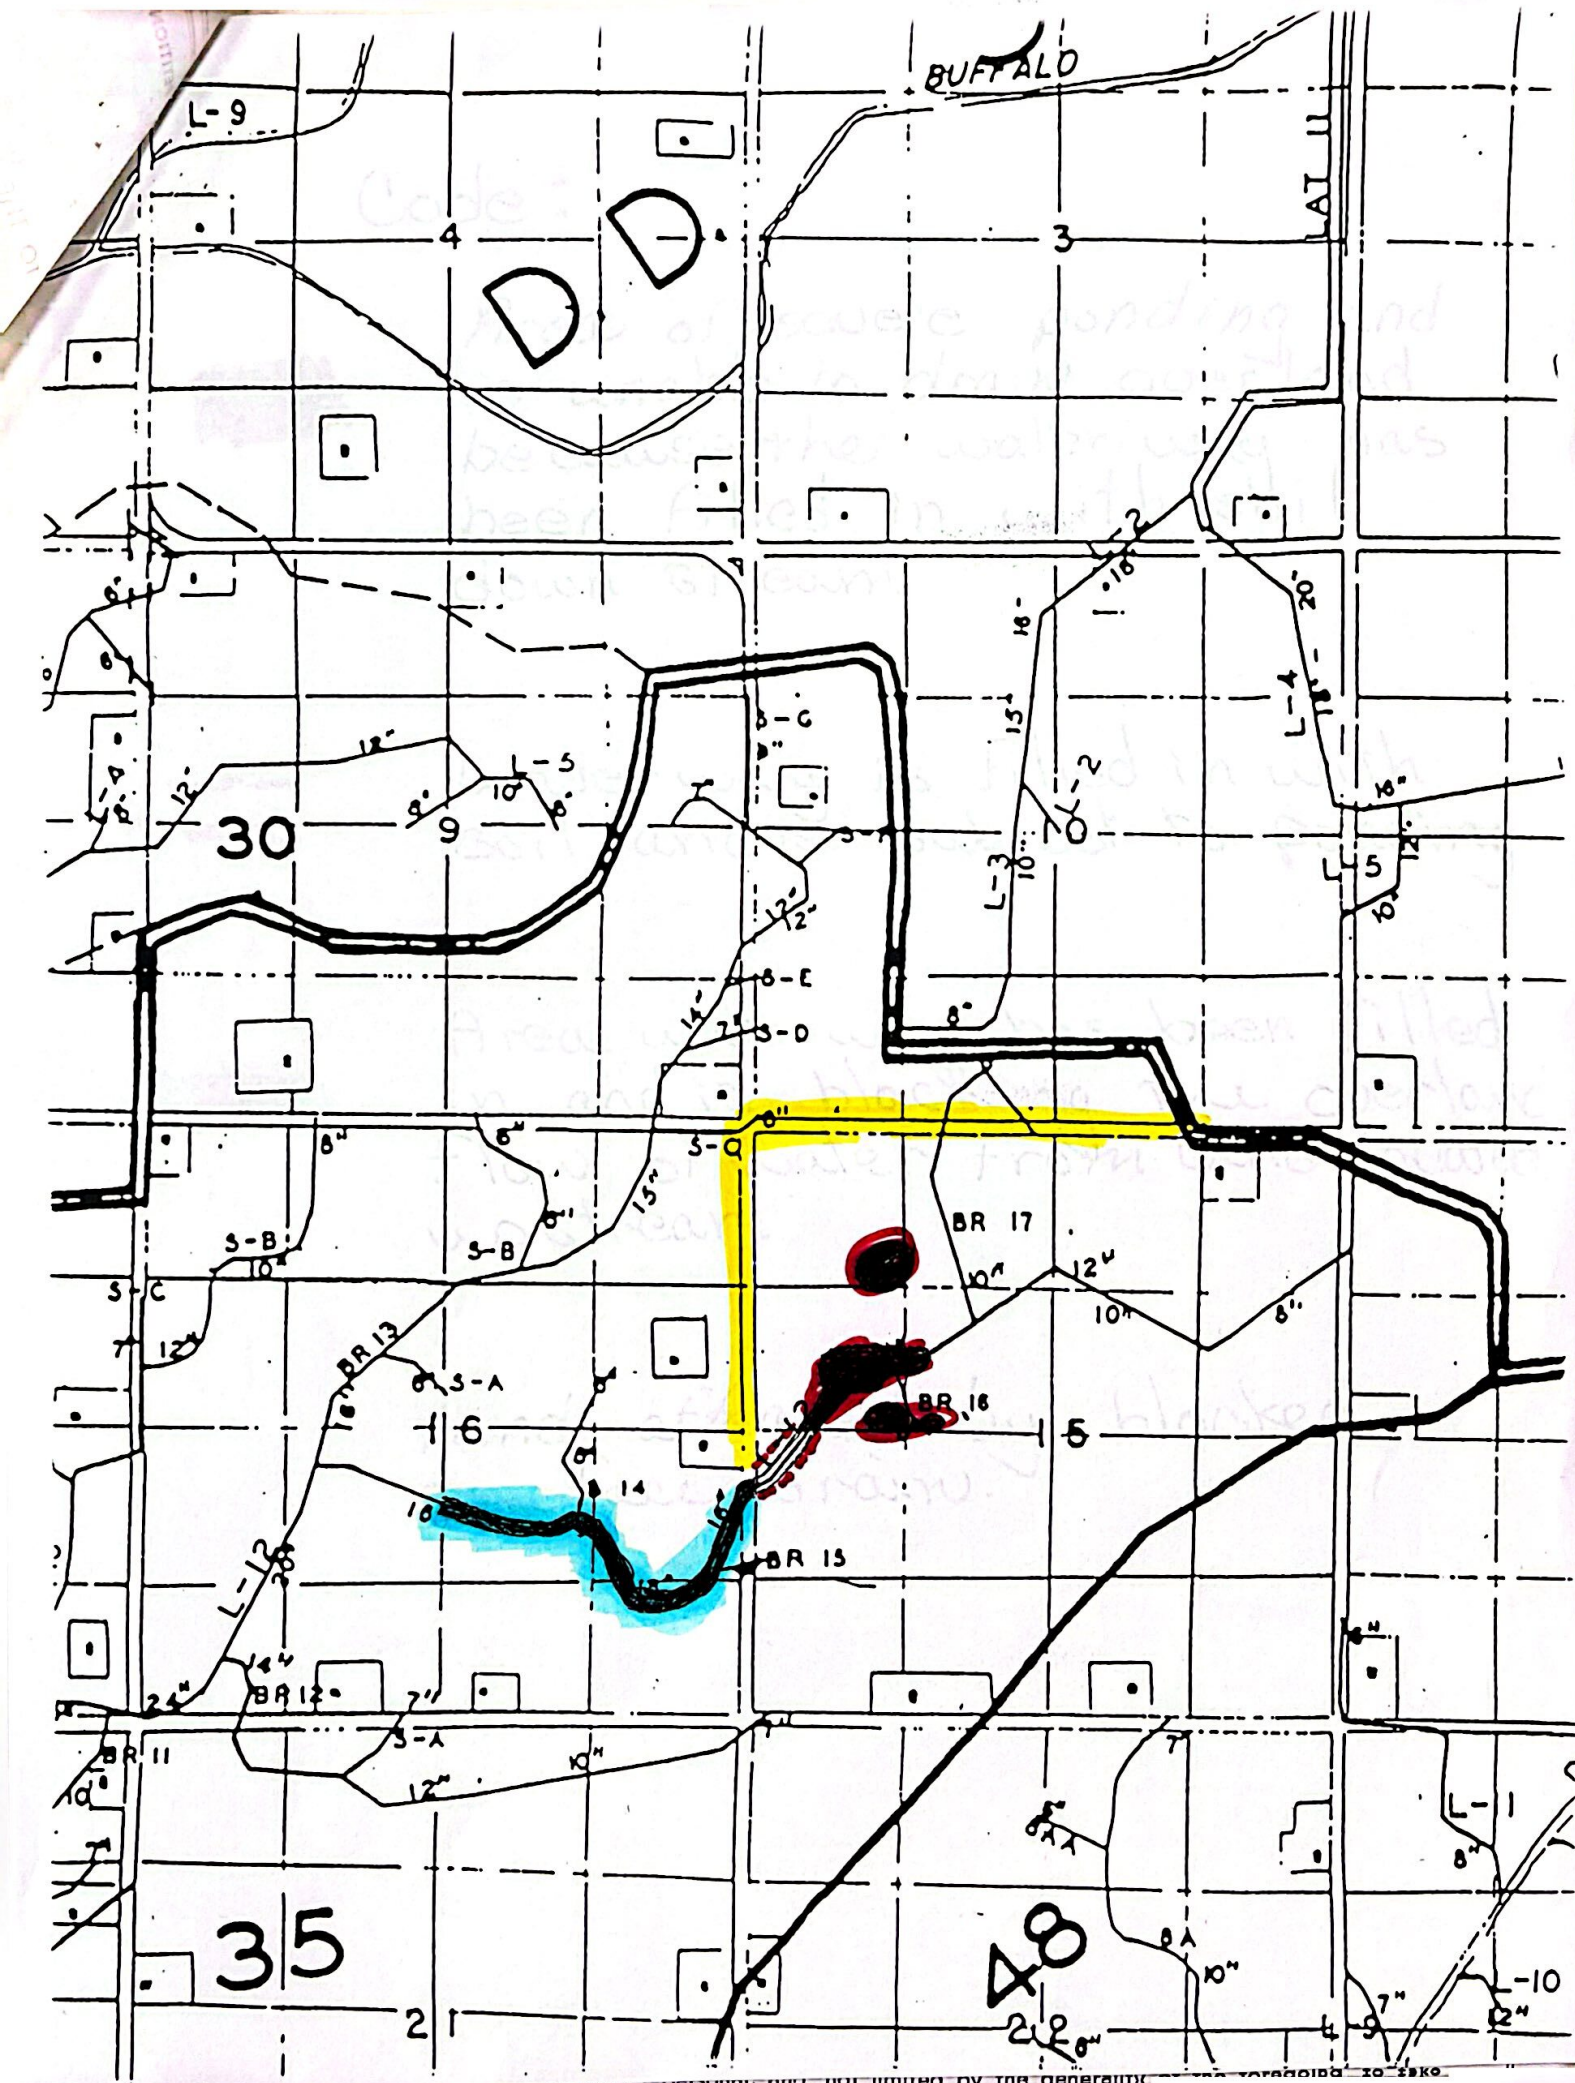
Lat 12

Area of severe ponding and is unable to drain overland because the water way has been filled in with soil down stream

Water way is filled in with soil and is subject to ponding

Area water way has been filled in and is blocking the overland flow of water from land located upstream

land affected by blocked surface drain.

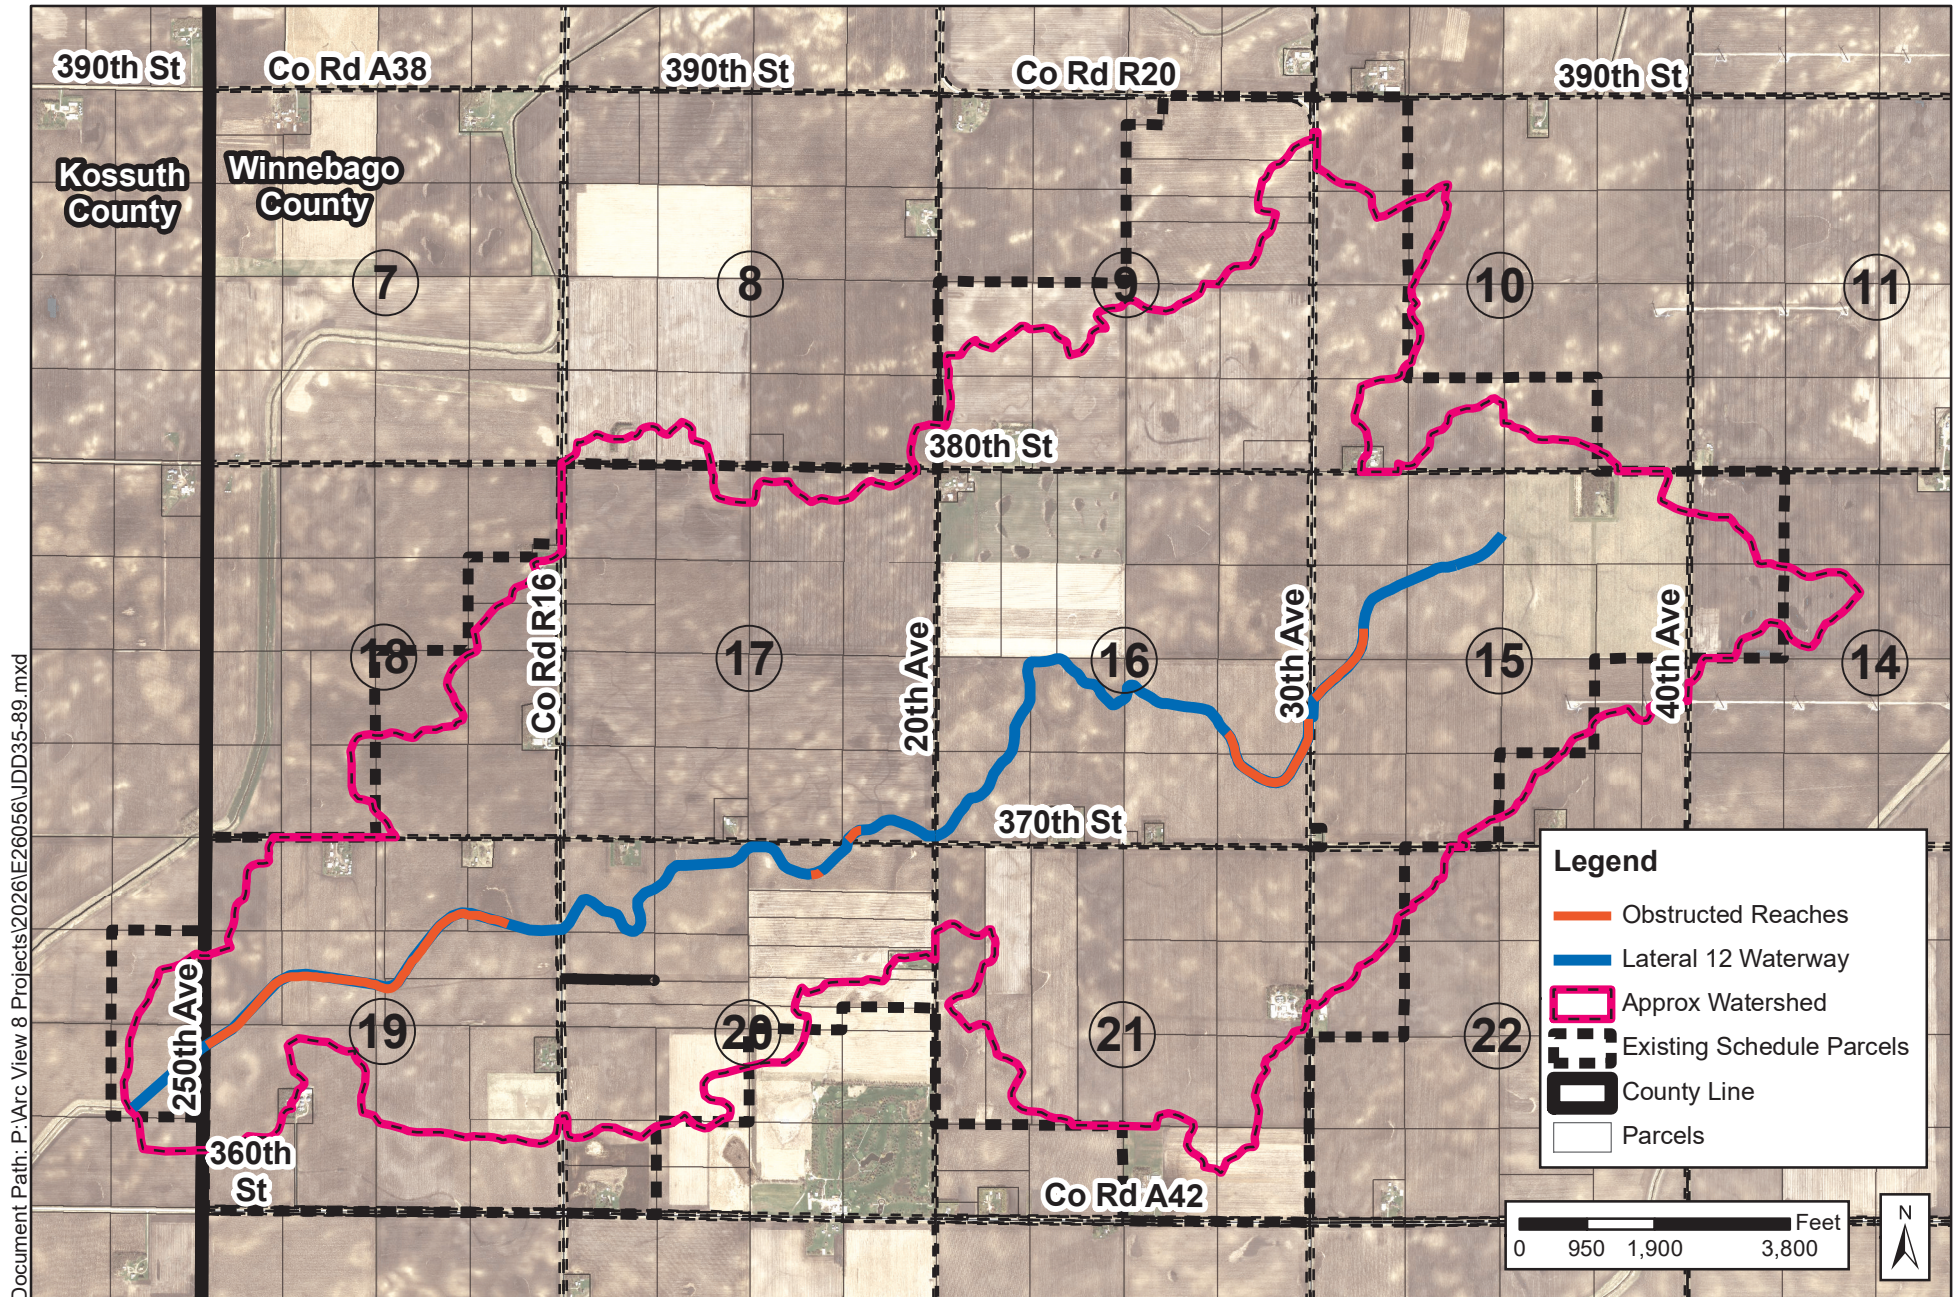
# Joint Drainage District No. 35-89 Lateral 12 Obstructed Reaches Map

| Lateral 12 Waterway Obstruction Reaches | | | | | |
| Start Station | End Station | Length, ft | Avg Depth, ft | Max Depth, ft* | Ponding Length, ft** |
| 14+50 | 66+00 | 5,150 | 1.0 | 1.5 | 2,500 |
| 122+00 | 123+50 | 150 | 0.5 | 0.5 | 600 |
| 129+50 | 132+00 | 250 | 0.5 | 1.0 | 400 |
| 208+00 | 229+50 | 2,150 | 0.7 | 1.5 | 1,000 |
| 233+00 | 245+50 | 1,250 | 0.5 | 0.9 | 1,900 |

1. Cleanout / re-grade the Lateral 12 waterway for approximately 8,950 feet, where obstructions have been identified via survey. This represents about 1/3<sup>rd</sup> of the length of the overall waterway. We would use our proposed best fit profile for this work rather than trying to recreate the original design profile.
2. If there is a desire to pursue drainage improvements in Lateral 12, a petition would need to be filed by one or more landowners in its benefited area.

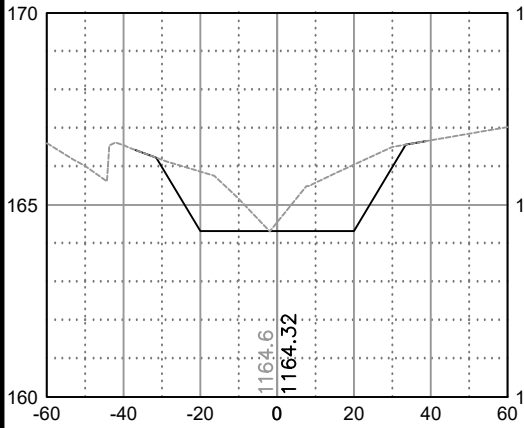
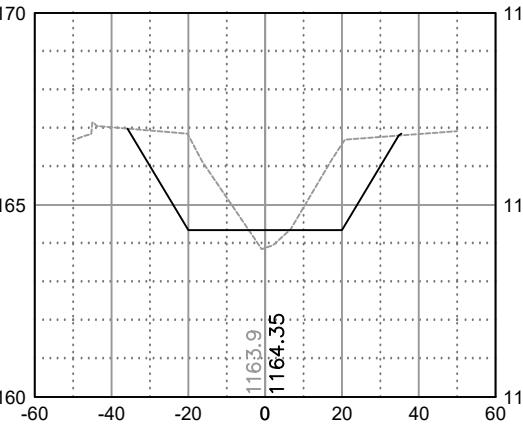
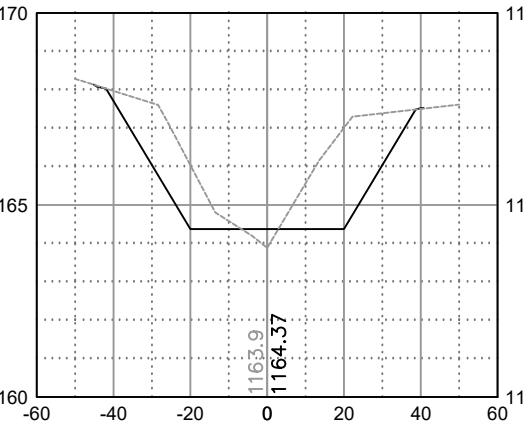
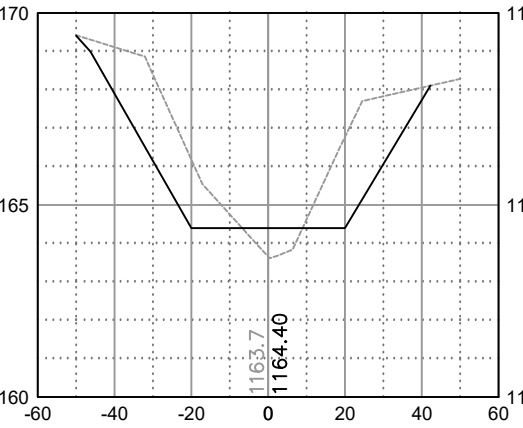
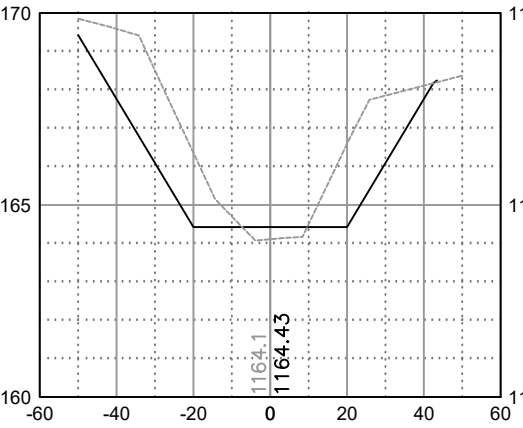
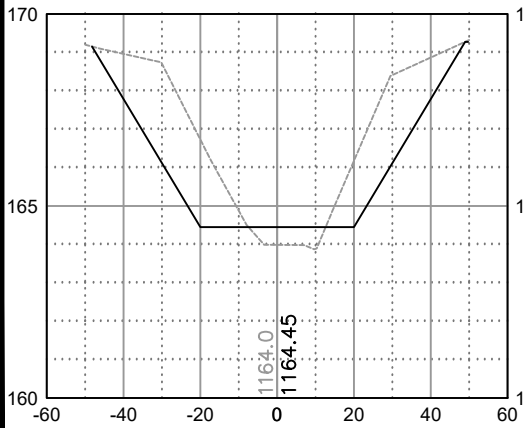
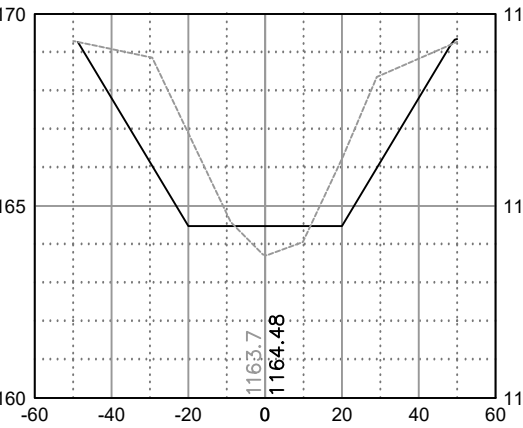
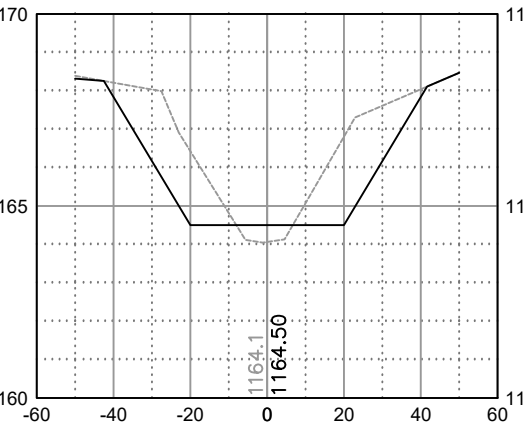
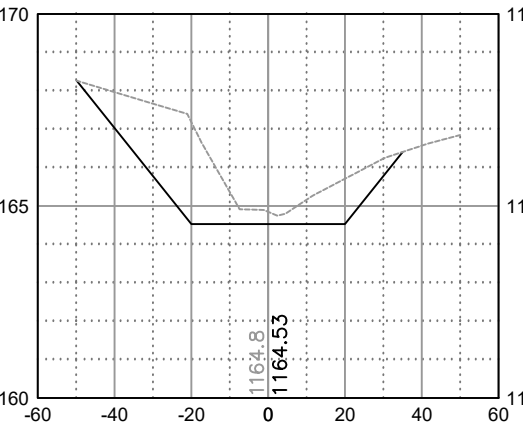
As can be seen in the enclosed cross-sectional views, in the reach from approximately STA 34 – 42 the waterway is quite deep and does not appear to have anywhere near a 40 foot wide bottom. We speculate that perhaps this reach was never excavated with a 40 foot wide bottom. The narrow corridor likely eroded, causing it to deepen below the design bottom elevation and was eventually seeded to grass (the only portion of the entire waterway that is grassed and not farmed). The original cut in this reach was over 2 ½ feet, which means the side slopes of the waterway was allowed to be 6:1 (rather than the 8:1 called for elsewhere). Widening/re-widening the waterway in this reach should strongly be considered.
