ENGINEER'S REPORT

DRAINAGE DISTRICT NO. 89 TILE REPAIR/IMPROVEMENTS WINNEBAGO COUNTY, IOWA

PROJECT NO: E22104

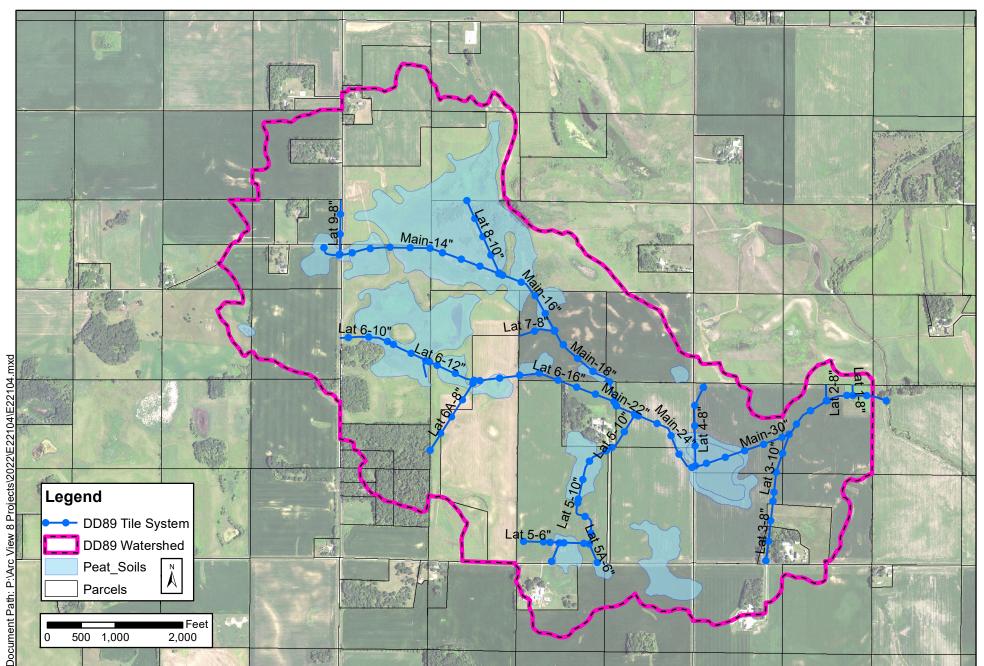
Drainage District No. 89 Peat Soils Map

There are issues with cover in several additional areas throughout the district. DD89 contains an estimated 184 acres of land comprised of peat soils. See attached map showing peat soil areas. These soils are located in depressional areas and are very high in organic matter. Once drained, the ground surface of these soils subside, or "sink". In comparing the profile of the ground when the tile system was installed with the ground profile today, we find that the ground over the Main Tile and Lateral 4 in the peat ground in the western portion of Section 23 has <u>subsided up to 4 feet</u>. In this area soil cover over the tile is often less than 1 foot. It also appears that the ground has subsided about 2 feet in the peat ground overlaying Lateral 5 tile. We did not complete a full survey of the tile system but anticipate that other areas of peat ground have also subsided a great deal.

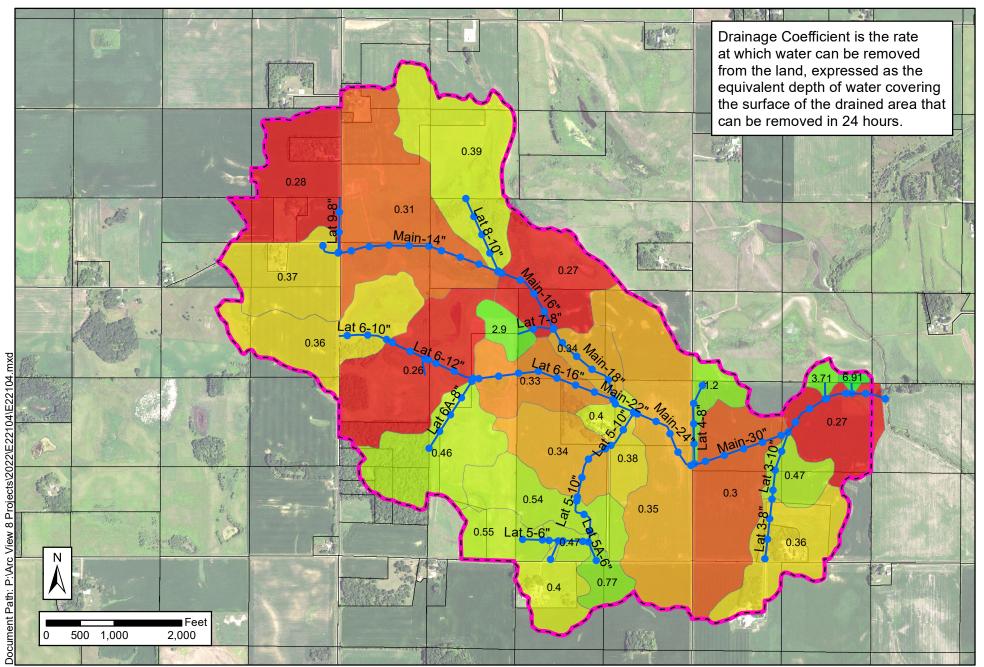
Drainage District No. 89 Drainage Coefficient Map

The original tile system appears to have generally been designed for a drainage coefficient between 1/4" and 1/3" per day, with some reaches being at or above 1/2" per day. The equivalent drainage coefficient (not considering the public lands) is at or above 1/2" per day for most of the laterals. Considering the public lands, it is our opinion that the tile in most need of improvement is the Main Tile from the outlet to where Lateral 5 Tile enters it.

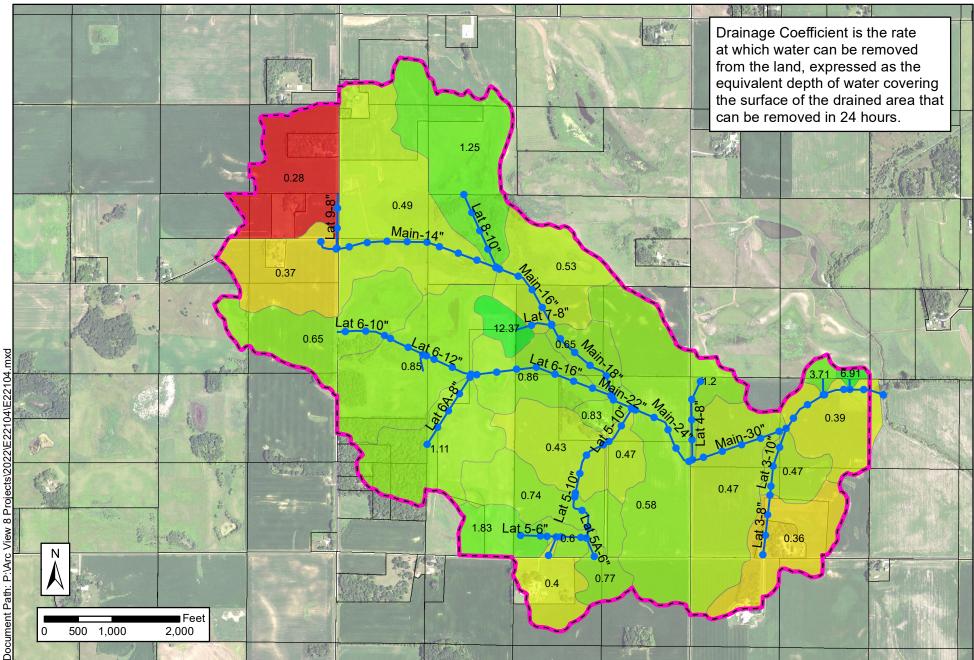
Drainage District No. 89 Equivalent Drainage Coefficient Map with Public Lands Removed

This district is somewhat unique in that approximately $1/3^{rd}$ of the land area is owned either by the State of Iowa, or Winnebago County. A large portion of the public land is part of a restored wetland complex. The drainage needs for this land differ from typical privately owned farmland utilized for row crop agriculture. The restored wetlands will use the tile system infrequently, and typically directly following a large rainfall event. Once the excess water is drained the tile system is fully available to the rest of the district for subsurface drainage needs. To account for this in analyzing the adequacy of the existing system, we have calculated an "equivalent drainage coefficient" which does not include the public land acres in the calculation.

It is our opinion that if the entire district were to be drained adequately for row crop agriculture a drainage coefficient of 3/4" – 1" per day would be required. Removing the public lands from the equation, we would recommend an equivalent drainage coefficient of at least 3/4" per day.

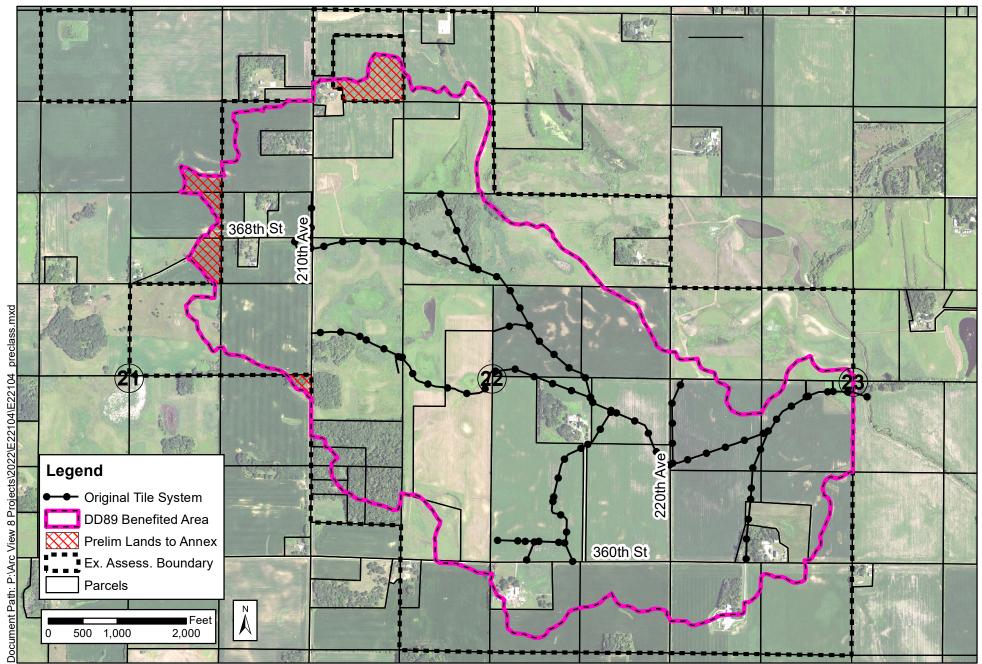
Drainage District No. 89 Preliminary Annexation Map

There are several parcels that are materially benefited by district facilities that are not included in the existing assessment schedule. We recommend annexing these lands into Drainage District No. 89, which would require further analysis, a separate report, and a public hearing. At this point in time it appears as though there are approximately 23 acres within 5 total parcels that would be annexed. See enclosed map.

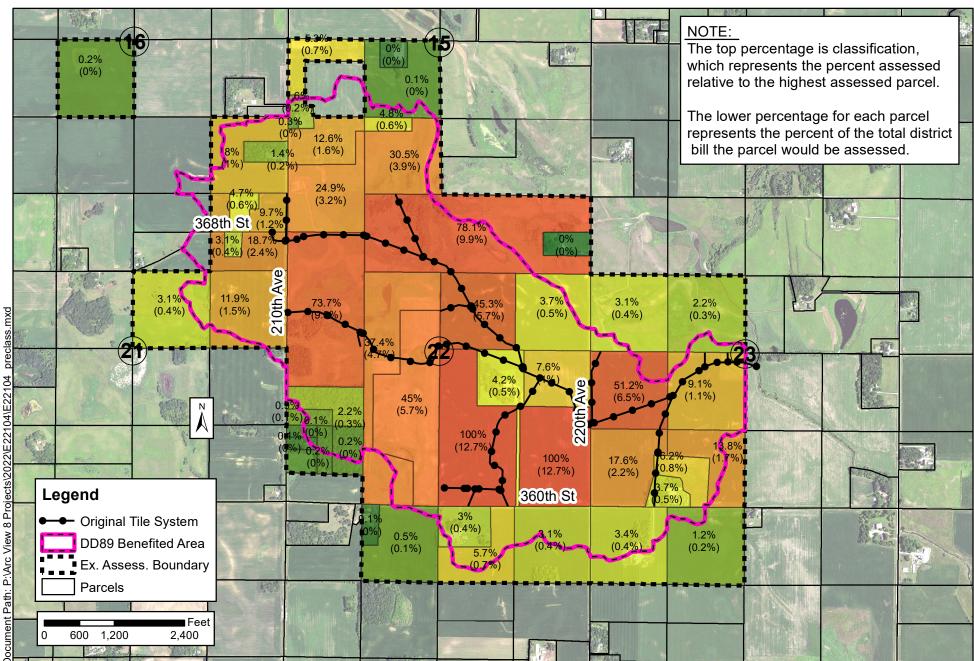
Drainage District No. 89 Existing Assessment Schedule

A map of the existing classification is enclosed. This district is still under its original assessment schedule from 1920. All district tile facilities are included in this single assessment schedule. Under this schedule all lands are assessed for work done on any tile in the district, regardless of whether the lands benefit from it. For example, parcels that drain into Lateral 3 tile would help pay for repairs to Lateral 5 Tile, which they do not use nor benefit from. The remedy for this is to develop separate assessment schedules for each district facility, to make the cost of improvements and future repairs more equitable. This process is called re-classification, and we recommend it be done regardless of what work is done on the district tile system. Re-classification is done by a classification commission which includes an engineer and two Winnebago County landowners who neither own nor have any interest in the lands being re-classified. A report would be filed and a public hearing would be held.
