Existing Facility Evaluation

The Winnebago County Public Safety Center is located at 216 South Clark Street in Forest City, Iowa. The building was originally the Forest City Municipal Hospital and was built in 1924. The original structure is a two story double wall masonry building with a basement. The foundation is formed concrete walls. The building is approximately 2,800 square foot per floor. The main heating is provided by a boiler installed in 1987 and radiant heat is provided by radiators. The roof top units provide the air conditioning and are over 20 years old. The roofing is a Firestone EPDM roofing system that is approximately 15 years old which appears to be in fair condition but has been patched several times. An elevator was installed with the original building.

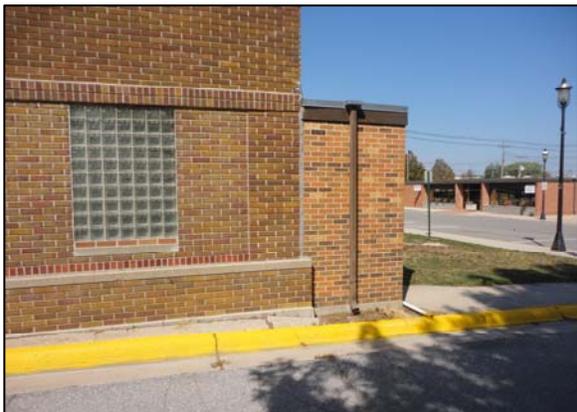
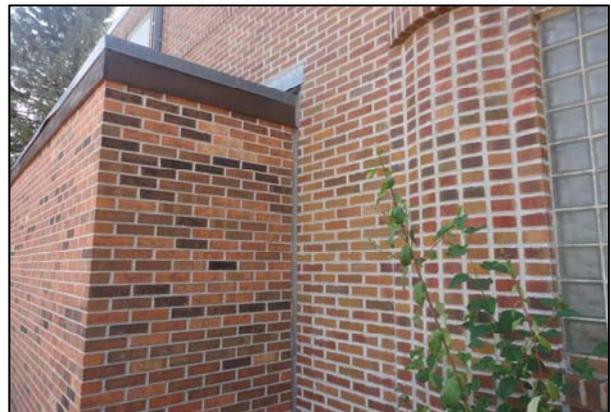
There are several exterior components of the building that have separated from the main structure and have been repaired with additional flashing and caulk. It is apparent some settling over the years has been experienced and maintenance will be consistently required to avoid water migration and additional damage from freezing weather conditions.

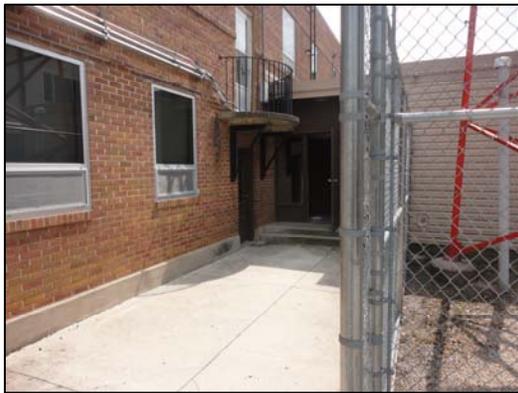
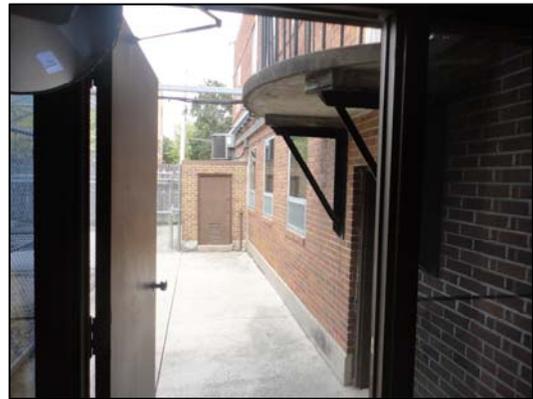
There are several balconies and structures attached to the building at this time. There are doors exiting to small balconies. These would appear to be safety hazards and security risks as well as a source for heat loss. The structures are old and should be removed and the doors removed and the openings filled. The concrete and masonry canopy at the front entrance is deteriorating. This presents a safety hazard to the public and should be repaired or removed. The fire escape from the second floor would need to remain but the anchoring systems should be checked on a yearly basis.

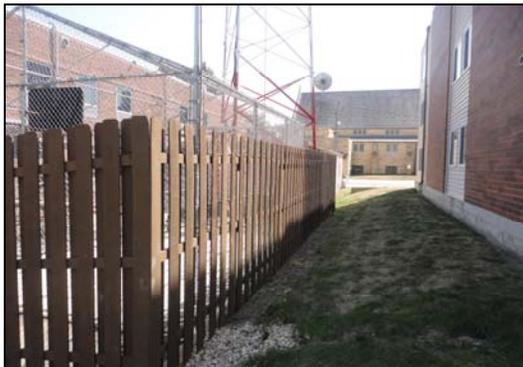
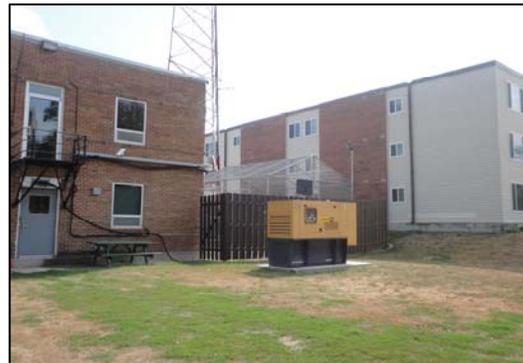
Inmate Outdoor Exercise

The outdoor exercise is located next to an apartment complex. Typically most facilities are moving away from an outdoor exercise area to avoid contraband being passed into the area and inmates being in view of the public. To move inmates to the exercise area they have to be taken through the non-secure section of the facility. The jail inspector has identified the concerns on all of his inspection reports of the safety of staff and citizens. The tower for the E-911 system is also located in this general area. Between moving inmates through the non-secure area and being located so close to the apartment complex should be cause for concern.

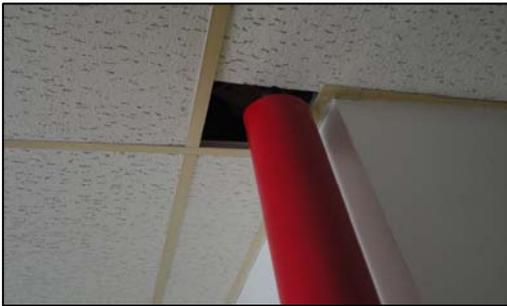
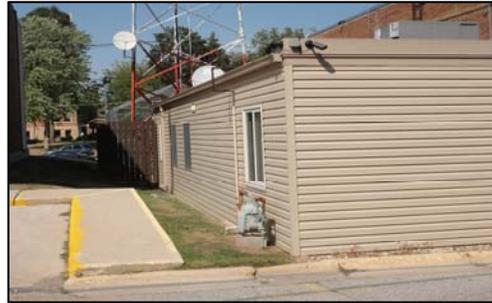
Single Story 1971 Addition

The addition is typical residential construction. The construction of the building is poor and problems are being experienced. The building is located directly next to the apartment complex parking lot. This side of the building has low quality residential windows facing the lot which offers little security to the building. The R-value of the windows is low allowing for heat loss.

A minimally pitched roof was installed on wood trusses which is more typical of commercial construction. It would appear that the roof trusses were not sized properly for this type of use as house jacks have been placed in several locations to brace the trusses that were sagging. Another problem is that the roof top unit was placed on the roof and it is anticipated that additional structural bracing should be installed.

The floor plan is poor and offers security risks from moving inmates through the building to get to the exercise area. Renovation of this building would be possible to an extent. The entrance facing the alley allows for ADA Accessibility to this section of the building.

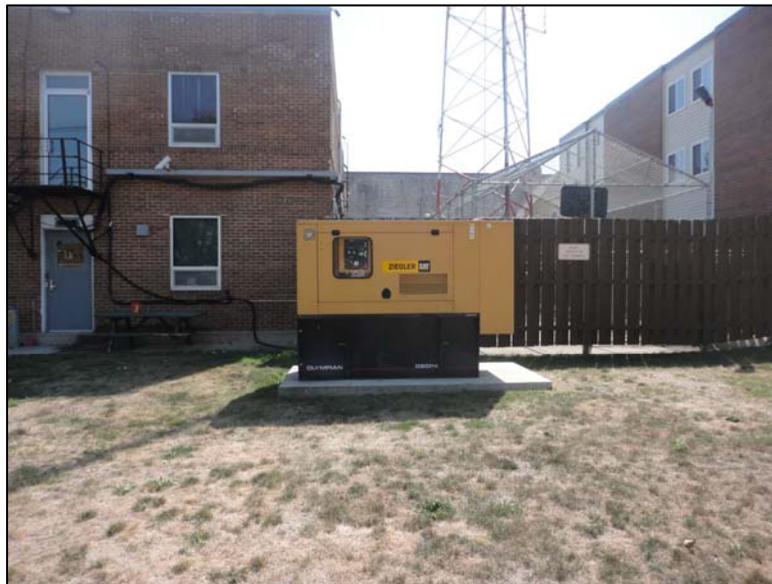
Emergency Generator

The emergency generator is a Caterpillar D80P4 575 KG which provides backup for the main components of the facility as well as the E-911 / Dispatch equipment. The unit is in good shape and is located outside of the facility.

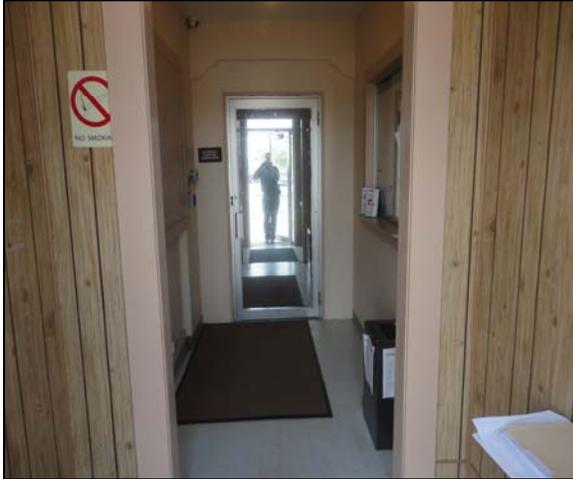
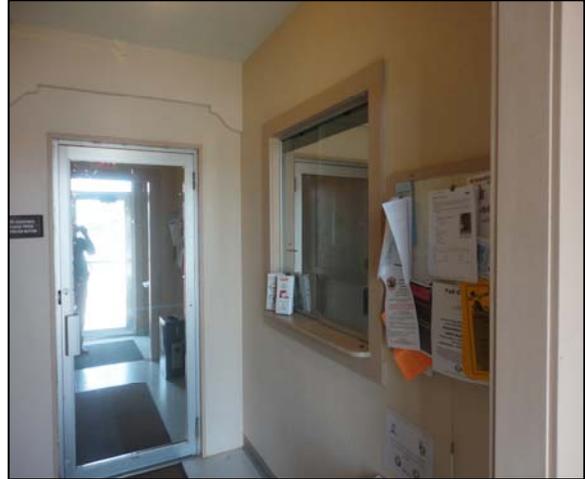
Vestibule

Although the front door has a handicap accessible sign on the door the step at the front entrance does not comply with ADA requirements. The transaction window is too high for any disabled person to complete transactions.

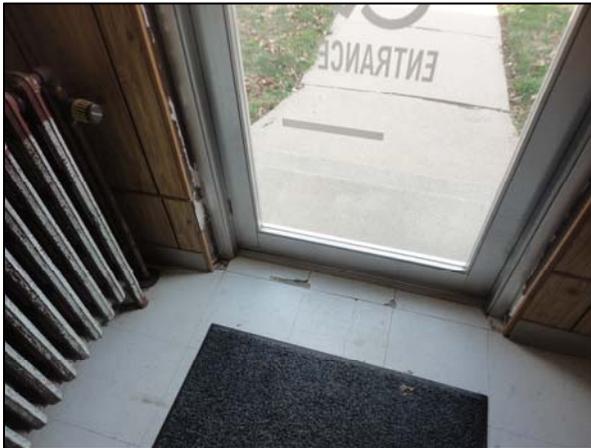
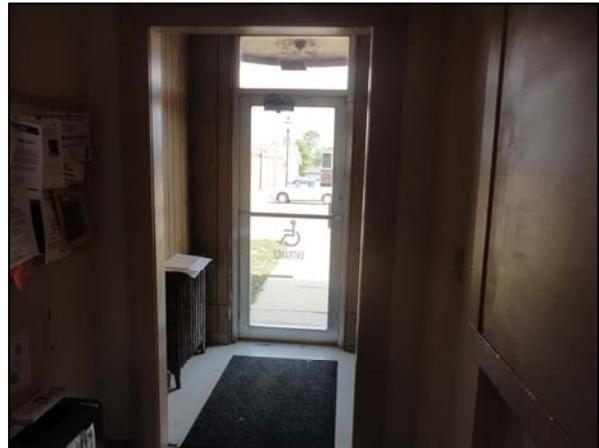
The canopy is disintegrating and will require repair or replacement for the safety of the public. The finishes are deteriorating especially around the front door and in need of repair.

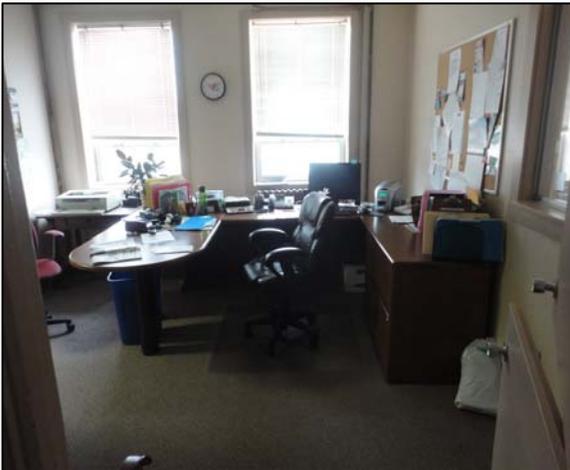
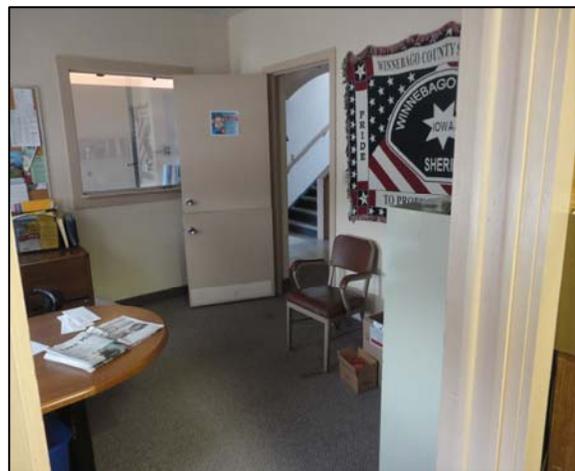
Civil Secretary / Reception

The area is extremely undersized to allow for efficient operations. There is room for 2 filing cabinets for record storage which means the Civil Secretary has to leave the area to obtain records on a consistent basis.

Due to the lack of a secure transaction window and door this area is unprotected from the public creating a very hazardous safety situation for the receptionist when dealing with the public. Modern facilities are working behind a secured and bulletproof reception area. The transaction counter is minimal and the public has no area to sit or fill out documents. This also means that the staff has to leave the window and go to the desk to complete forms. They either have to lock the window or leave it unsecured.

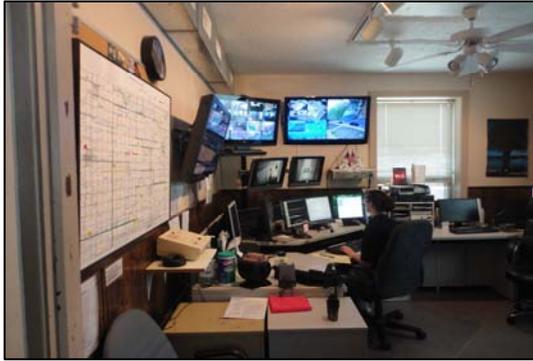
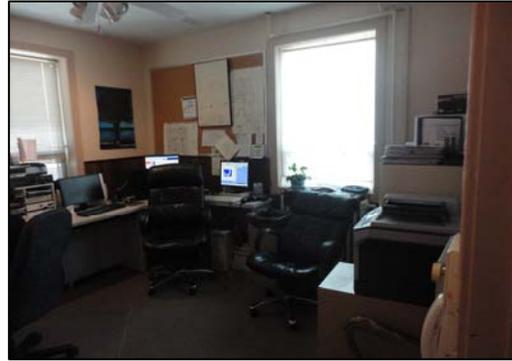
E-911 / Dispatch

There are several concerns and deficiencies to be considered and space requirements are insufficient. The dispatch stations have no counter space to perform their duties because of the amount of equipment and size of the room. Critical duties are being performed in this area including emergency response calls, dispatching, monitoring cameras for the jail and providing periodic checks on the inmates as required by State Jail Codes. To provide efficient responses and complete all tracking records the work space needs to be increased.

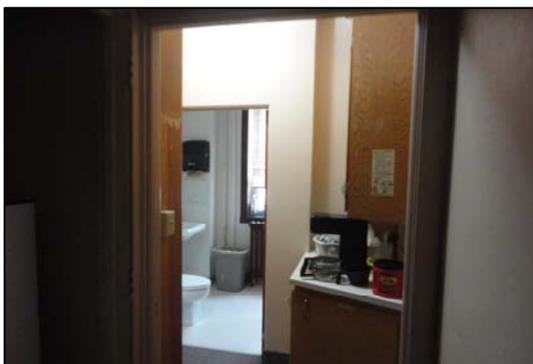
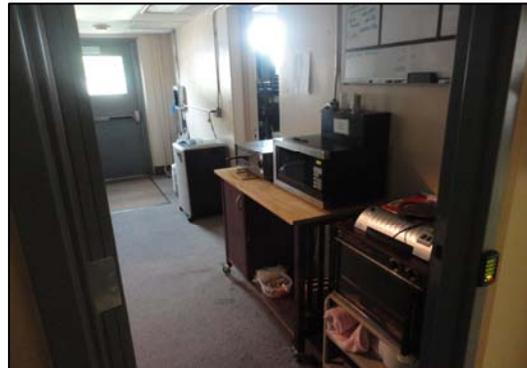
Typically the E-911 / Dispatch Centers have a direct restroom and small kitchenette with sink and microwave as it is difficult to leave their stations unattended. Currently there is a small table located in the corridor acting as a break station and a small coffee counter off of the restroom. There is no sink or water available and the nearest water would be from the lavatory in the adjacent restroom.

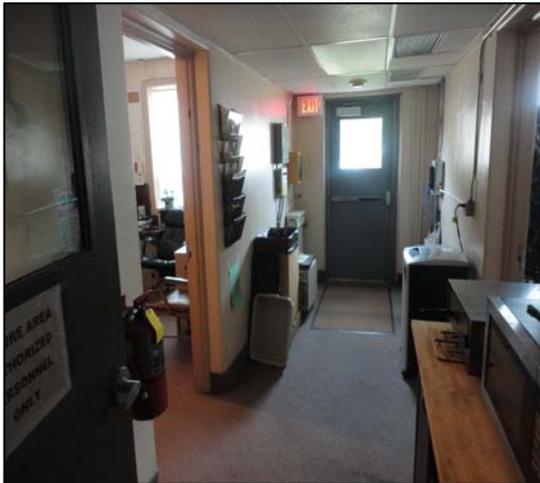
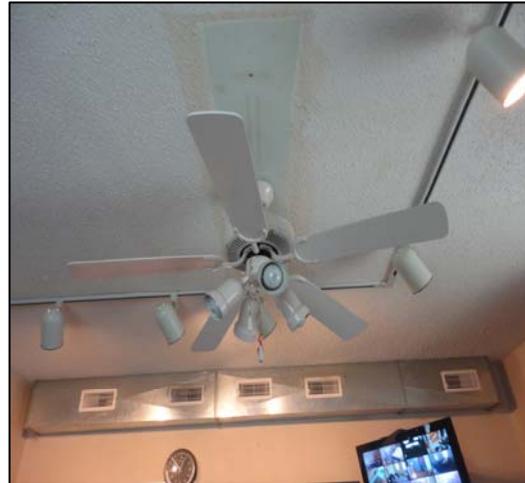
The room and corridor are hardened walls so all fixtures and conduits are surface mounted. The monitoring systems for the fire alarm and emergency generator have been surface mounted in the corridors. Due to the amount of heat put off from the equipment, additional air conditioning had to be surface mounted and a ceiling fan added. Additional surface mounted light tracks along with the ceiling fan have been installed to provide lighting. The standard bulbs and flood lights are not typical of the standard lighting required for this type of operation. The windows in the room are an energy efficient security type of window for protection from severe weather conditions and security. The record storage and filing is minimal and they have had to use the equipment storage and corridor for additional filing room. The hardened walls do not allow for efficient renovation or mechanical construction.

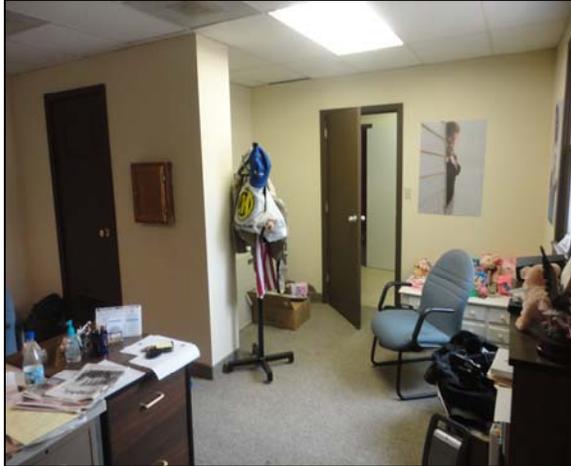
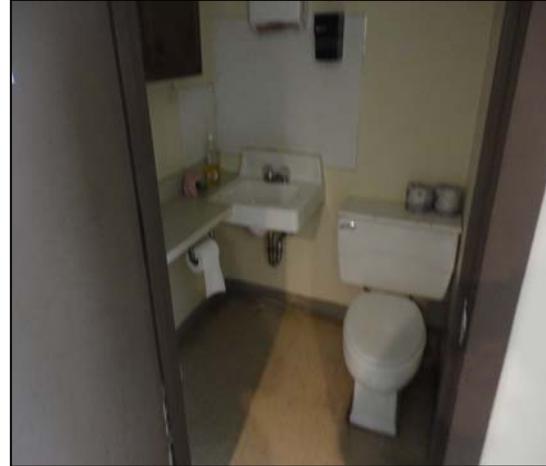
Sheriff's Office

The entire 1971 addition has been renovated on several occasions and has resulted in spaces that are chopped up and inefficient. The Sheriff's office is located away from the Civil Secretary and public vestibule. Public would need to be escorted to the office. To provide efficient operations and coordination with the Civil Secretary it would be better to have the Sheriff's office in close proximity to the Civil Secretary's office.

The office should be a secured area for record storage as well as safety of the Sheriff. The windows are located next to the parking area for the apartment complex and are easily accessible from the exterior of the building. As the windows are of poor quality it would be recommended to replace the windows with bulletproof security glazing. Security of record storage is required by HIPAA Regulations as confidential records of employees are filed in the office.

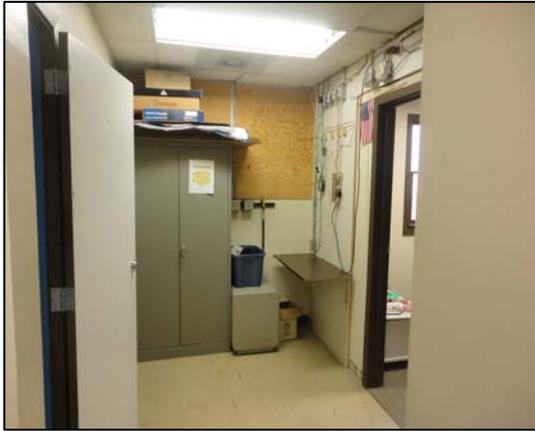
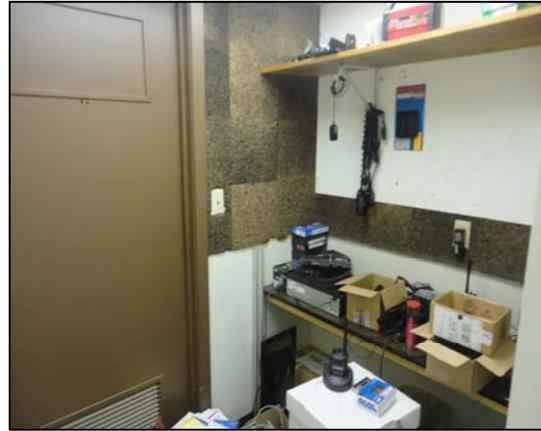
Armory / Storage

This current floor plan makes this area unusable. There should be access control to identify who has accessed the armory. Electrical power is not accessible to charge radios and all electrical is surface mounted. Due to the layout there is not enough space to store equipment or protective gear. Security is an issue.

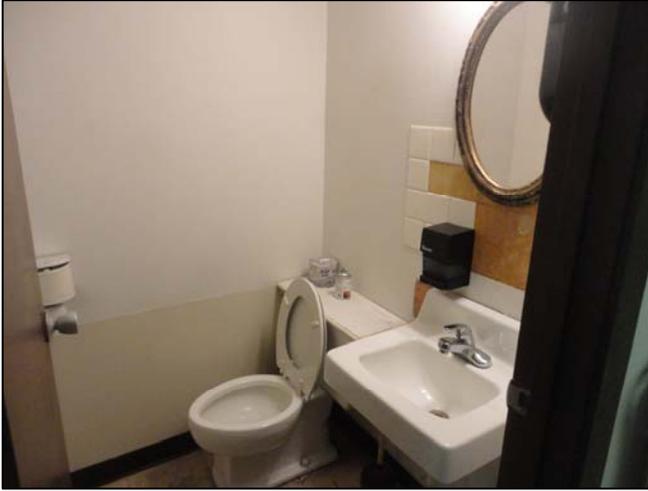
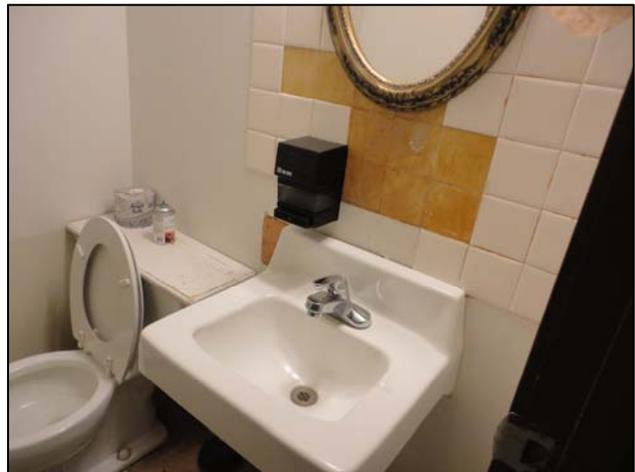
Staff Restroom 1971 Addition

The restroom will not meet ADA Compliance and is remote from the public and staff.

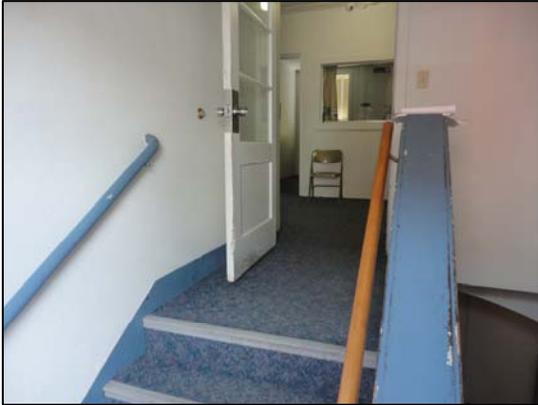
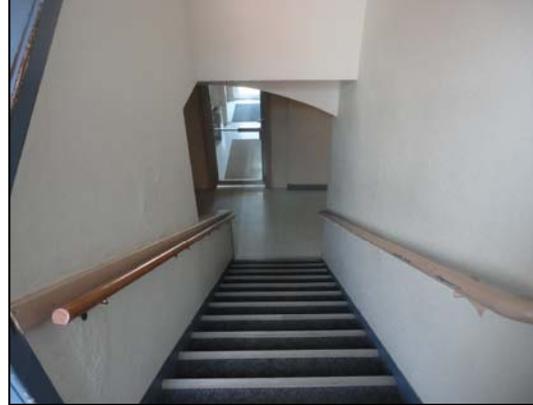
Stairway

The stairway is currently open at the bottom level and has a door at the upper level. Typically the stairwell needs to be a fire rated assembly. If any renovations are made to the existing facility the stairway will be required to be fire rated. There is a door on the second landing leading to a small elevated concrete balcony outside. This is one of the balconies that we are recommending to be removed due to the condition noted in the building section. The door could then be filled in to avoid heat loss and eliminate any safety hazards.

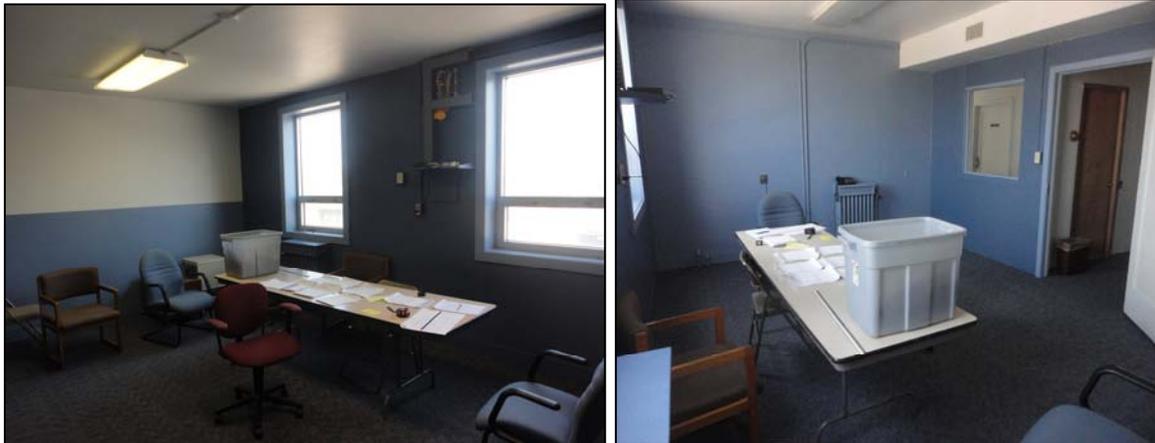
Reserve / Squad Room

All fixtures and conduits are surface mounted due to the hardened construction of the walls. There are minimal power and phone outlets available and no data outlets were observed. Air conditioning was added by installation of a soffit along the west side of the building. The air conditioning is insufficient to maintain a comfortable temperature if a large group is utilizing the room. The door to the room is 3'-6" that allowed for hospital beds to be moved which takes up a lot of space in the room. There is a window that accesses the evidence processing area. It would be preferable that this window be in filled for security of evidence.

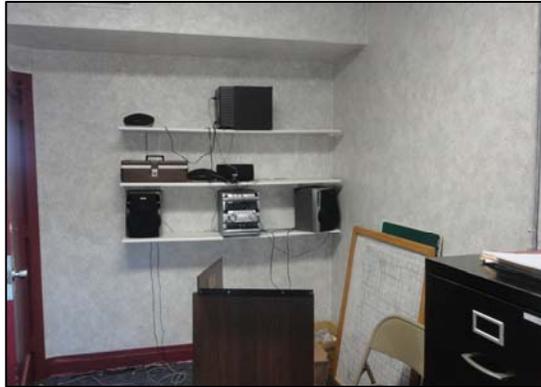
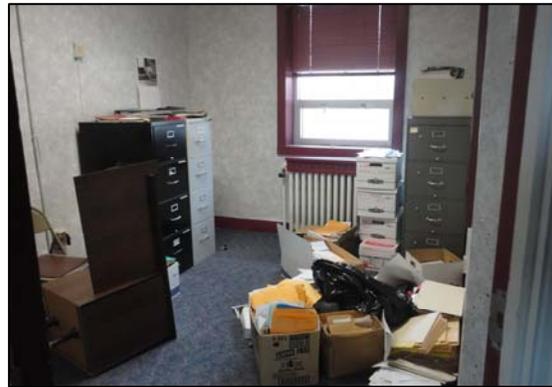
Record Storage Second Floor

This room has modified on several occasions. The south wall has built in cabinets as this use to serve as the nursery for the hospital. The cabinetry extends into the restroom adjacent to this room and takes up a good portion of the restroom. Due to the cabinetry and layout of the room and uses for other functions is limited. Power and phone outlets are minimal and no data outlets were observed.

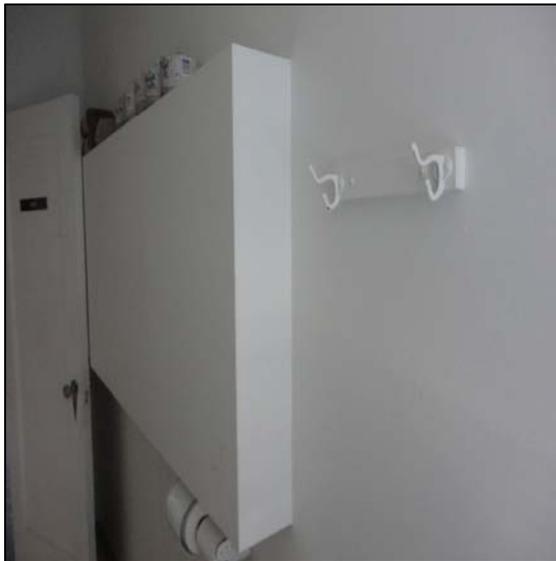
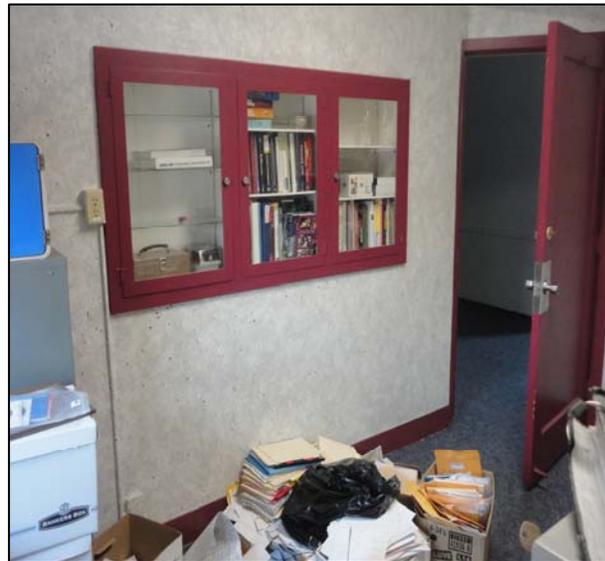
Staff Restrooms Second Floor

The first restroom is located next to the record storage and across from the conference room. The restroom is 45 square feet. It is long and extremely narrow with the cabinets from record storage protruding into the space. There is an old out of use shower located in the room. All the plumbing is surface mounted and the space can't meet ADA requirements. The south wall is part of the elevator shaft so the space cannot be expanded and changing any plumbing would be an issue. Given the condition of the plumbing and the limited space, it does not even work efficiently for staff.

The second restroom is located on the opposite side of the elevator shaft and across from the conference room. The room has been renovated many times and is 60 square feet. There is currently a lavatory with a sink base. The toilet has been located in an old closet that you almost have to back into. This space will not meet ADA and has limited use given the toilet location.

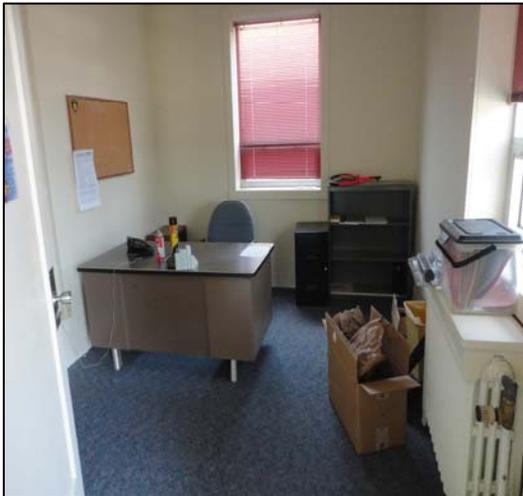
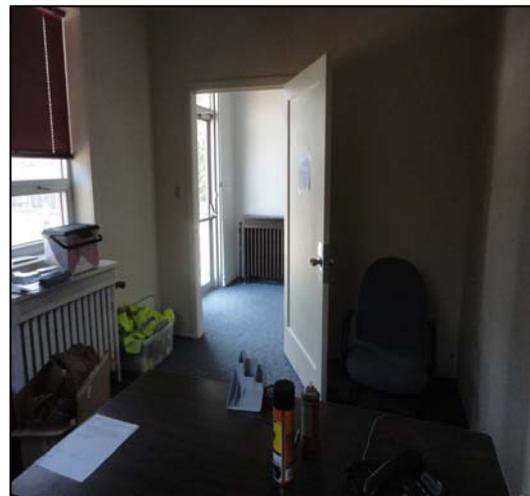
Deputy's Office Second Floor

This office has a sufficient layout to accommodate office furniture. The office has surface mounted power and telephone but does not have any data outlets. Use of a computer would allow the deputy to utilize the office more and complete tasks more efficiently. The lighting is bad and needs replaced. Heat is provided through a radiator which the piping is showing signs of deterioration and water damage is visible at the floor. The office is at the end of the air conditioning run and very little air is being provided to this room. The walls are hardened structures which does not allow for simple renovation.

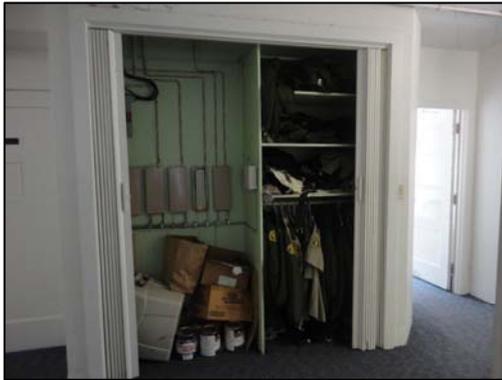
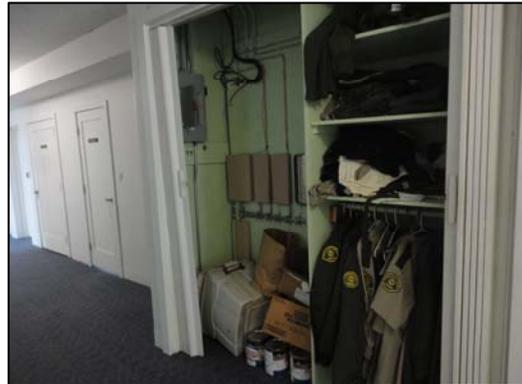
Typically any utility room needs to be in a fire rated room per fire code. The sliding partition does not meet any fire rating. There is minimal room for the uniform storage and any renovation of the building will require renovation of the room.

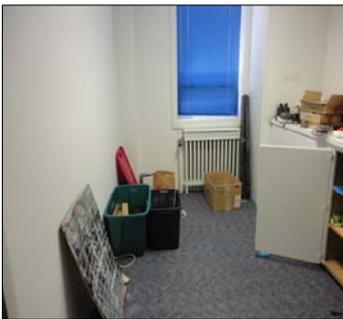
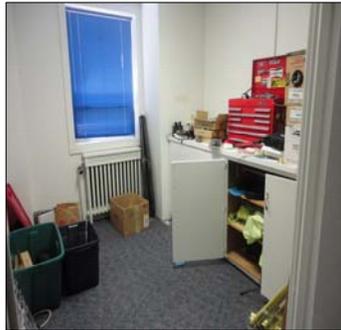
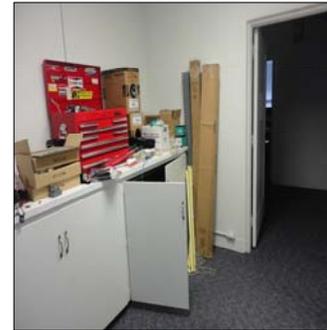
Storage Second Floor

The cabinets take up about half of the room. The cabinets could be removed but the area is still too small for an office. Renovations could be made to accommodate other storage.

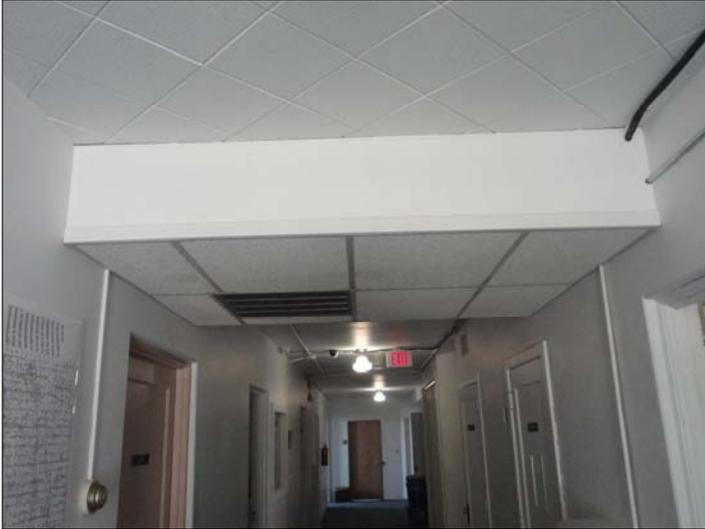
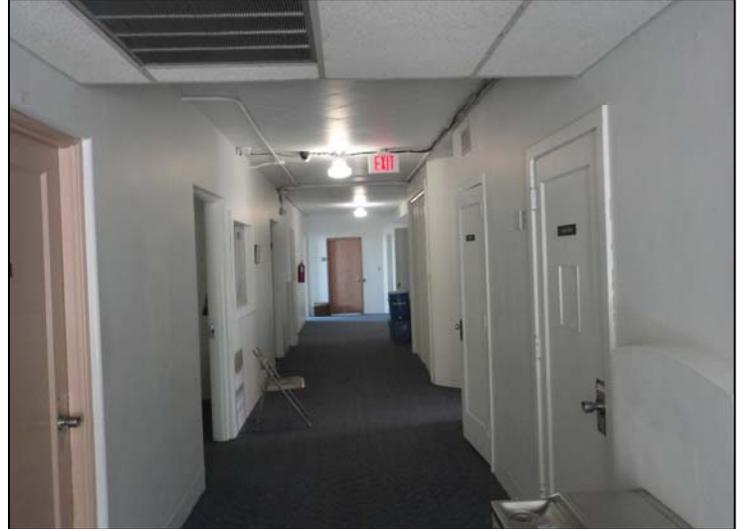
Upstairs Corridors

The corridor comprises approximately one third of the second floor available space. The doors from the rooms to the corridor are not fire rated doors. If renovations were completed fire code would require all doors to be fire rated. Renovation of the corridor would not be practical as they are bearing walls and hardened construction. All electrical, fire alarm, HVAC duct work and other upgrades have had to be surface mounted due to the hardened construction. The fire escape will require maintenance and some modification.

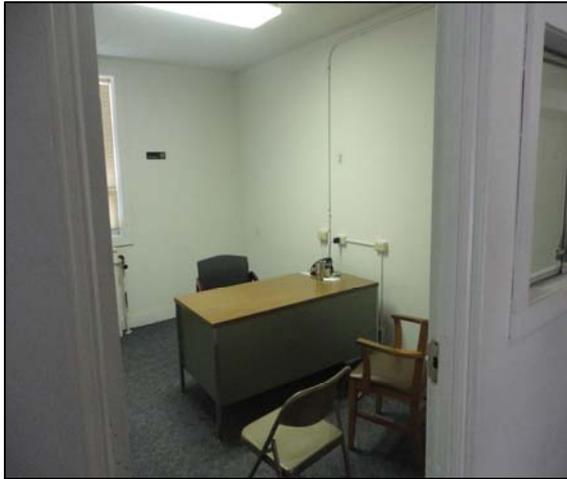
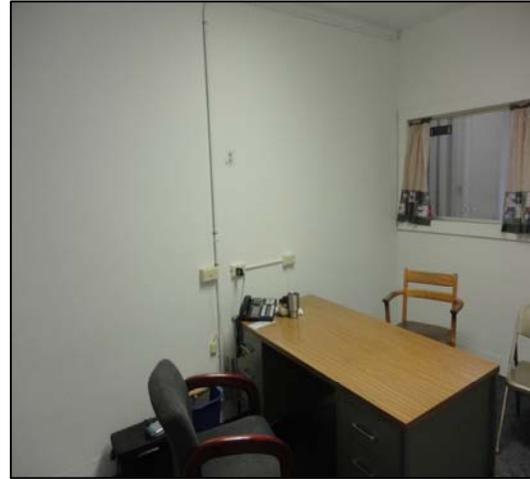
DOC / Probation / Parole Office

The room size is sufficient for the officer to perform their duties. The upstairs is not ADA accessible which could present a problem with a disabled individual. The room is remote from almost everyone as the deputies and emergency management may be on patrol and not in their offices. This presents a safety risk to the officer if one of the individuals becomes violent. It would be difficult to be heard if assistance or help was required. There is also a window in the room to the corridor. This could infringe on any privacy required. Any public checking in to meet with the officer would need to be escorted upstairs.

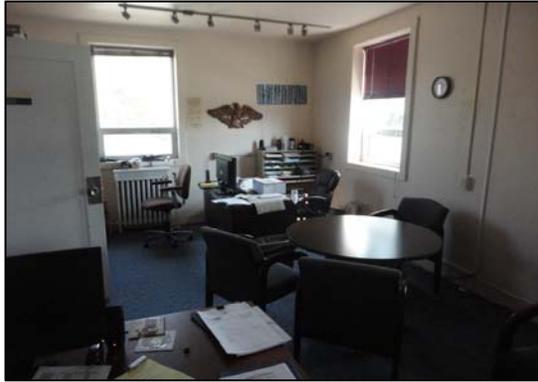
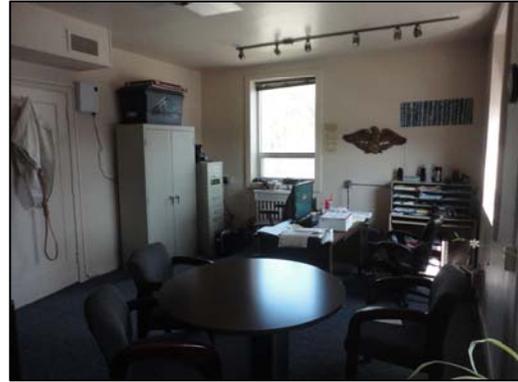
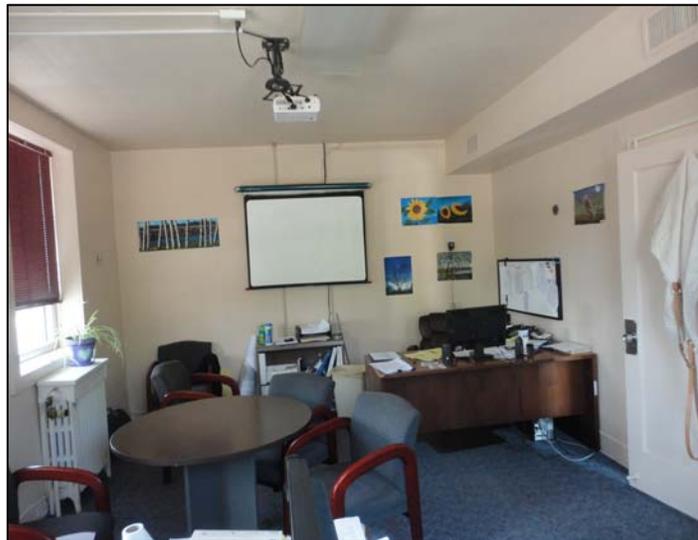
Emergency Management Office

There are minimal power, telephone and data outlets available. All fixtures, conduits and boxes are surface mounted.

The windows are standard windows which should be a security type of window to withstand severe weather conditions. This room is at the end of the air conditioning run and air flow is minimal making it difficult to maintain the temperature of the room.

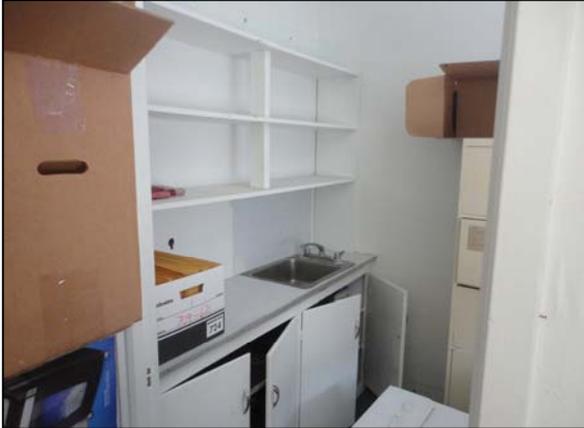
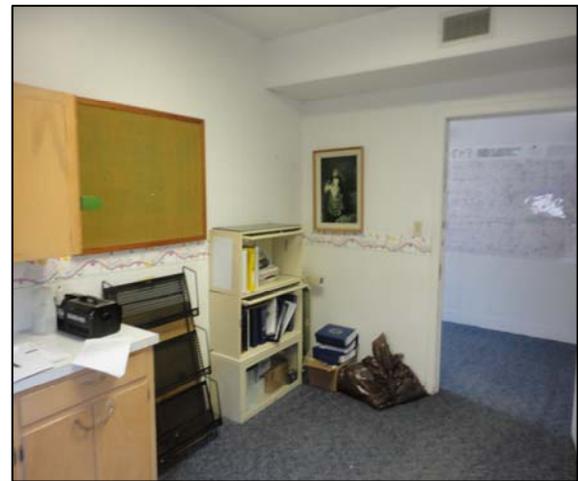
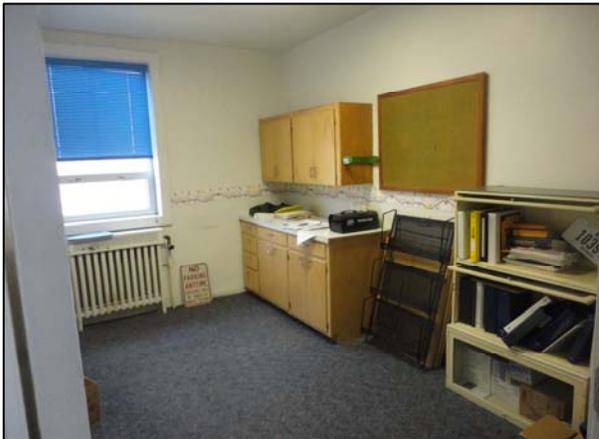
Emergency Management Storage

Typically emergency management would want to store materials where they could be easily accessible for loading in the case of an event. The room is large enough for storage but a lot of the space is wasted with the cabinet layout especially with the counter and sink in the kitchen. No renovation has occurred in this area.

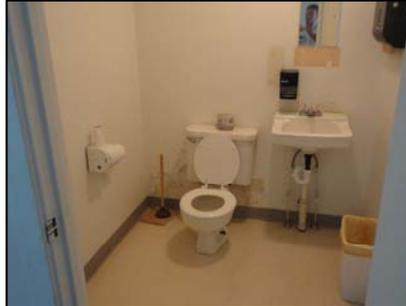
Staff / Public Toilet

The toilet would be very close to handicap accessible. The roof has leaked in this location and the ceiling tile is in poor condition. There are stains on the finishes from leaking plumbing. There have been some problems with the plumbing which is evident from the plunger located next to the toilet. The lavatory would need to have protective coverings on the plumbing to meet handicap accessibility. Realistically handicap accessibility should not be an issue being located on the second floor but the conditions of the room would give the public a poor impression.

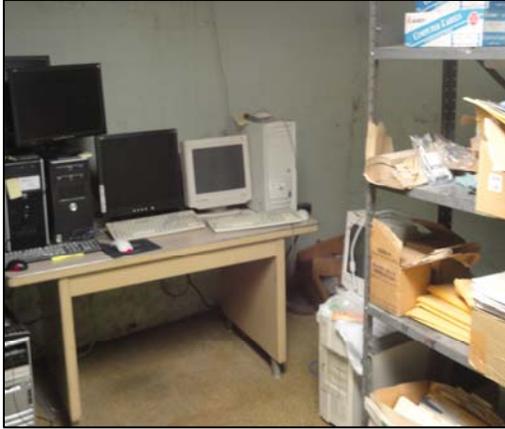
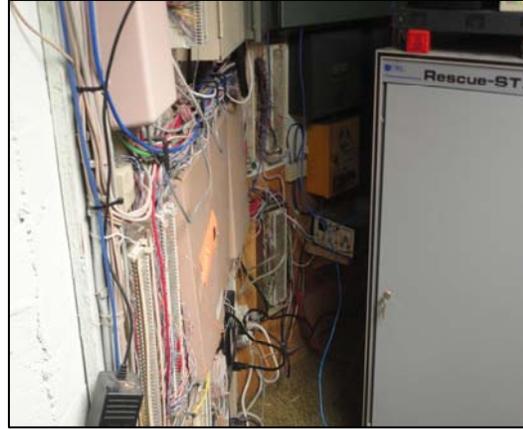
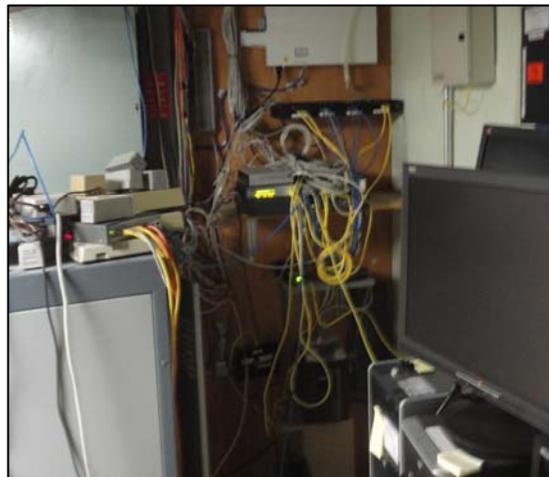
Telecommunication / Radio Equipment Room

The equipment is housed in the southwest room in the basement. There is a small desk for a computer for anyone needing to adjust programs of the equipment. The equipment itself puts out additional heat in the basement. The high moisture levels, dust, and heat are not good for the equipment. The radio equipment is the lifeline for the E-911 and Dispatch.

Additional power and data lines have been installed to accommodate the equipment. Lines have been run throughout the basement to the different first floor locations and to E-911 / Dispatch. The basement has experienced flooding over the years from the amount of piping, leaks through the foundation and major leaks from the elevator penthouse.

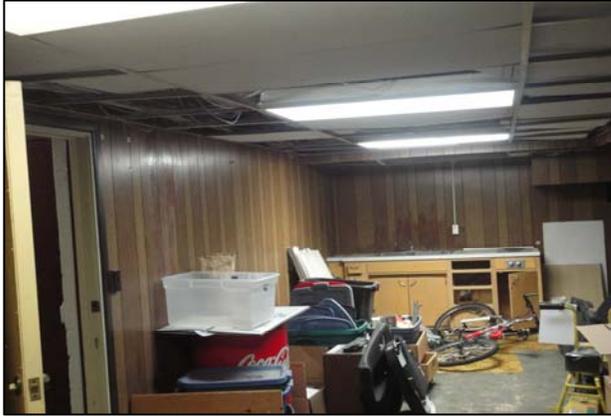
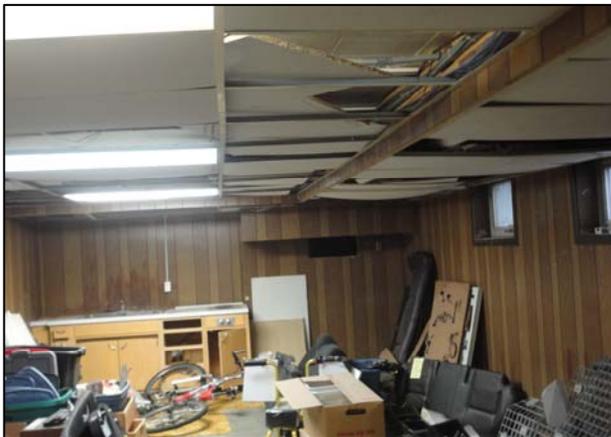
Storage Room

Due to the leaks and flooding, the items that can be stored in this area are limited. Ceilings are water damaged and mold can be observed. Panels have been removed to repair piping and to run cabling. Floor tiles are delaminating from the floor due to exposure to water.

It would be recommended that a professional firm specializing in removal of hazardous material be hired. All ceilings, paneling, shelving should be removed and disposed of legally. The firm should then clean up any hazardous materials including the delaminated floor tile.

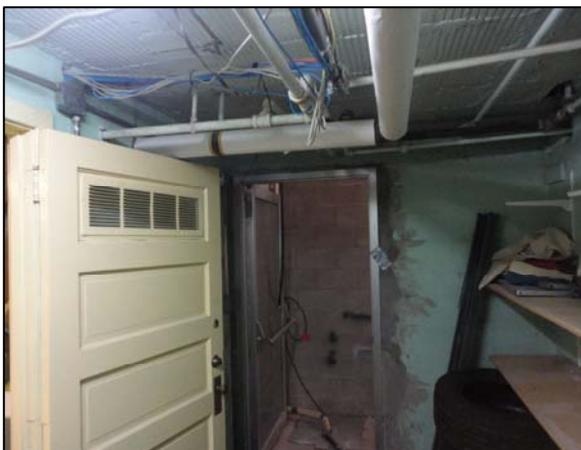
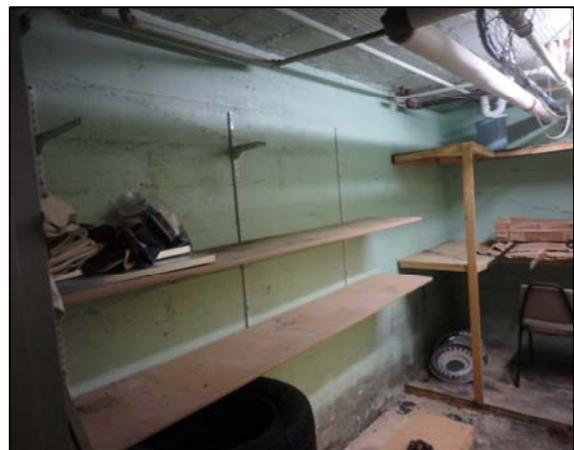
Small Storage to Stairs

Shelving has been installed over the years for possible storage. There are pipes over the shelving that have leaked and currently are leaking. There is a bucket on one shelf catching the water. The only real use for the area is to run piping and access the exterior stairway

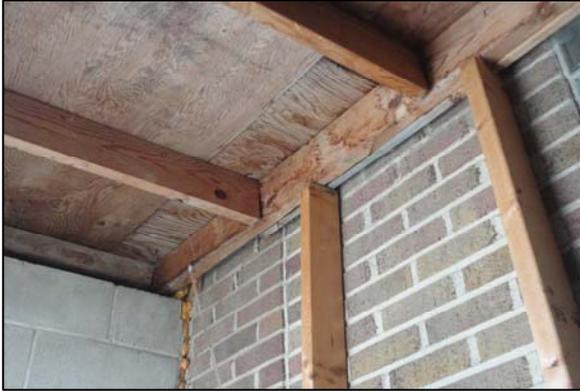
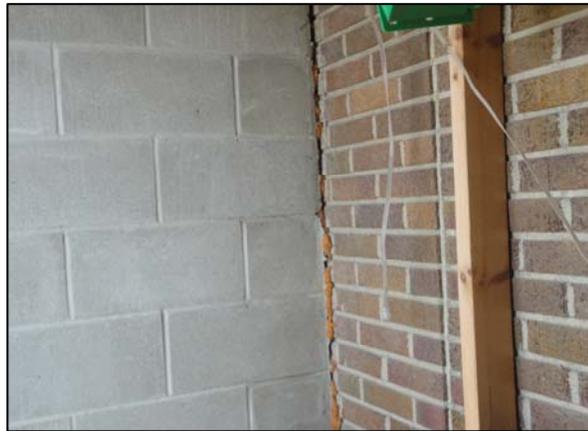
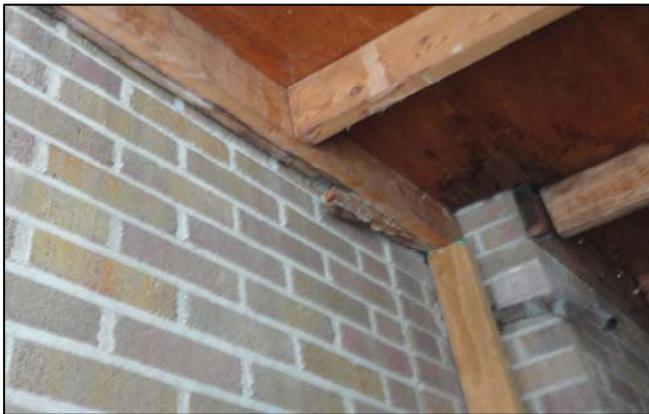
Exterior Stairs

These are the emergency stairs to the exterior of the building. The building for the stairs is pulling away from the main building. These voids have been foamed and caulked on the exterior. Additional flashing has been installed at the building connection to prevent leaking. Additional wood blocking has been added to support the roof and water damage is evident.

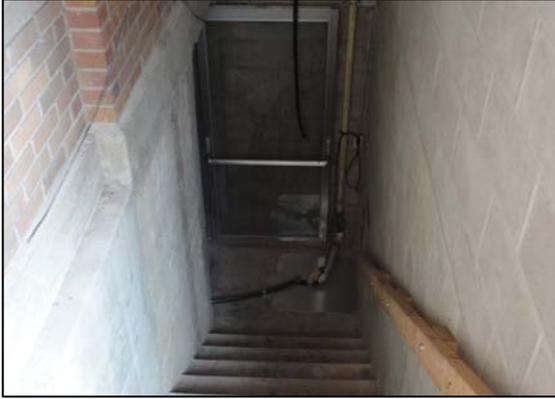
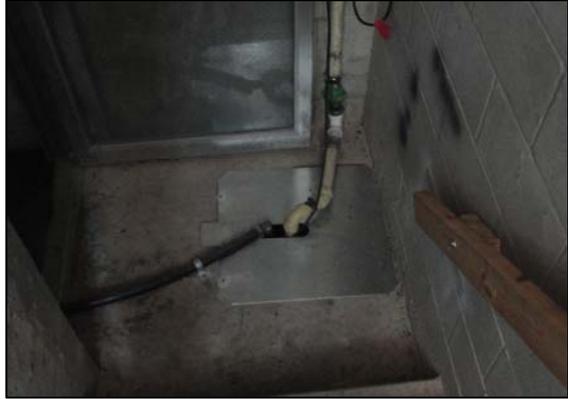
There is a sump pump with a light gauge galvanized cover at the bottom of the stairs. All other sump pumps in the basement are piped across the floor to this pump which pumps the water to the exterior of the building. The piping on the floor and the sump at the bottom of the stairs creates a safety hazard.

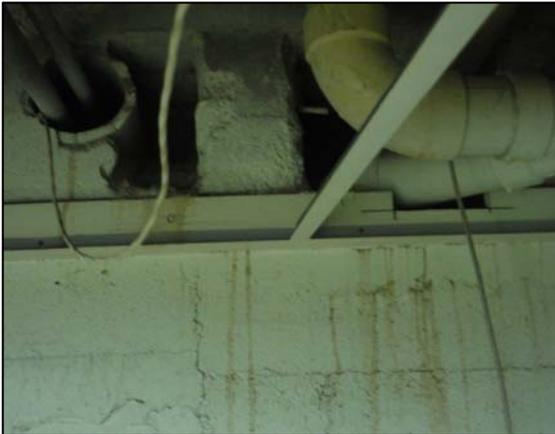
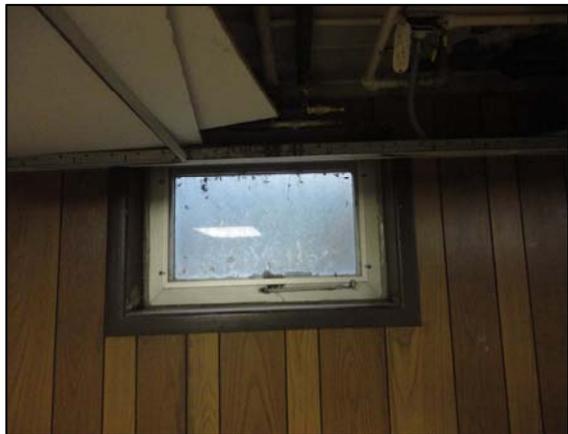
There are signs of water damage and mold at many locations. You can see it around pipes that have leaked, old windows, at the foundations walls, and other areas.

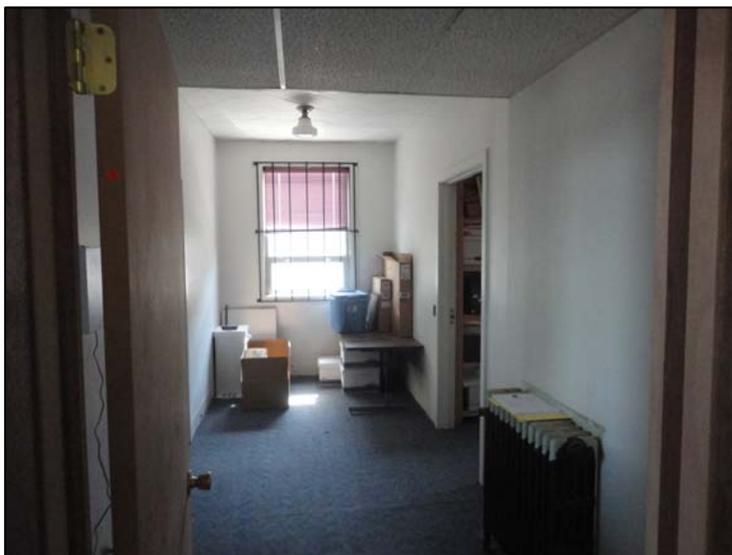
Evidence Process

Typically there is a desk and computer station for deputies to fill out the necessary filings for the evidence. Computer access is not available in this area and the space requirements are not sufficient to meet the operational needs. This room would typically have a sink with an emergency eye wash for clean up and safety from exposure to dangerous substances during processing. Large evidence can't be stored in evidence with the multiple doors and location on the second floor. The window to the conference room and standard solid core door presents security issues for access to evidence. The doors to evidence storage are minimum security allowing access to the evidence storage rooms that are only to be entered by the master of evidence and Sheriff. Any access to these rooms by other individuals could be considered as contamination of evidence.

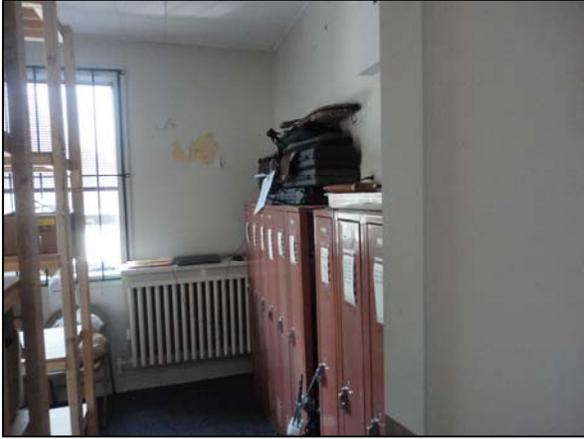
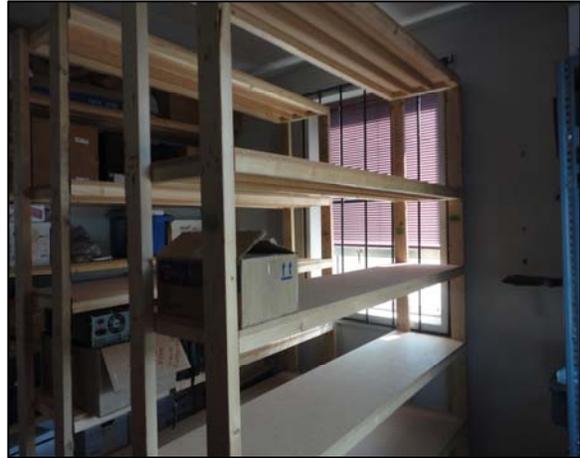
Evidence Storage

The space is insufficient to meet the storage needs. There should be a computer for the master of evidence to enter and catalog evidence into the storage. There needs to be an evidence pass through cabinet to allow deputies processing evidence to insert the evidence so the master of evidence can process the evidence into storage without the deputy entering the room. At this time the master of evidence would have to accompany the deputy to complete the process which is an inefficient use of personnel. The minimum security doors from processing create a security issue. Typically there would be a monitored access control monitoring who has entered the room. Storage on the second floor is inefficient for processing and storing evidence.
