Existing Facility Evaluation

The Winnebago County Public Safety Center is located at 216 South Clark Street in Forest City, Iowa. The building was originally the Forest City Municipal Hospital and was built in 1924. The original structure is a two story double wall masonry building with a basement. The foundation is formed concrete walls. The building is approximately 2,800 square foot per floor. The main heating is provided by a boiler installed in 1987 and radiant heat is provided by radiators. The roof top units provide the air conditioning and are over 20 years old. The roofing is a Firestone EPDM roofing system that is approximately 15 years old which appears to be in fair condition but has been patched several times. An elevator was installed with the original building.

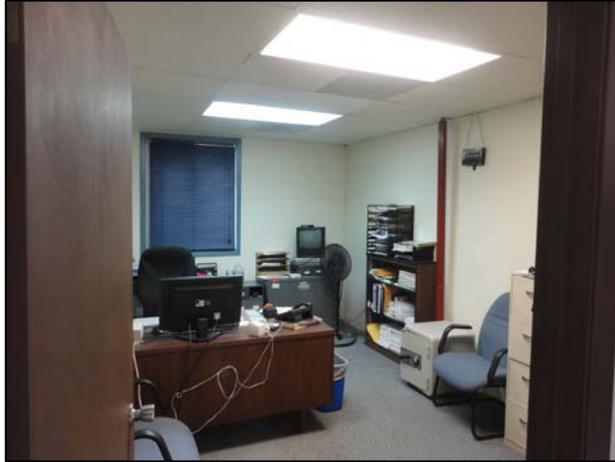
Jail Administrator

Although the office is 160 square feet the layout being narrow and long does not provide sufficient space for the operations required. It is located in a non-secure wing of the building allowing for escape from several areas of the building. The windows are of standard residential construction with easy access from the exterior presenting security issues to the staff and jail. This has been noted in the State Jail Inspection reports on several occasions.

The room should have sufficient space for a small conference table for meetings with the staff, public and inmates. This area needs to be secured to protect personnel files which the residential non-secure door does not provide. This could be a liability for State privacy issues. If an inmate would become upset or violent there is not any means of securing the inmate. Safety could become an issue with the obstacles and equipment in the room if an inmate became violent.

The only space for monitors is behind the desk due to the room layout which adds difficulty to be able to view the monitors consistently. The room is inefficient for the necessary duties to be performed.

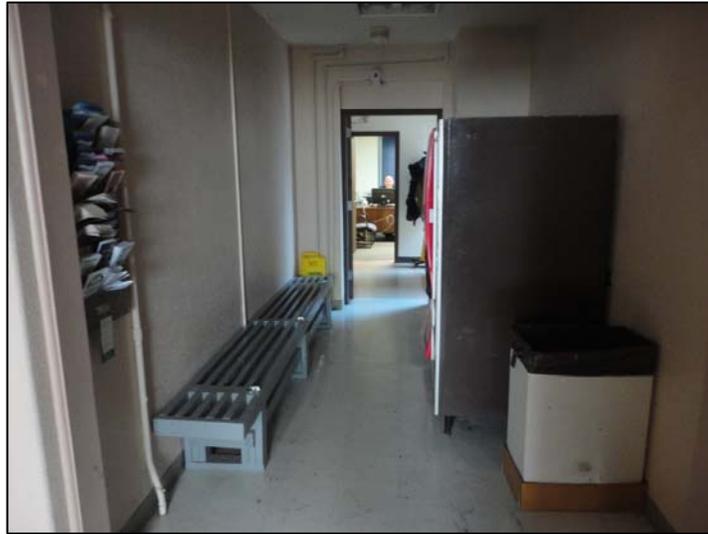
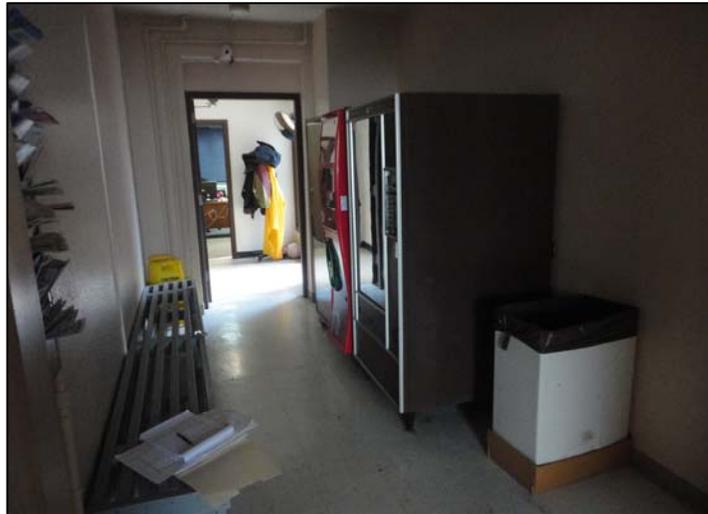
Jail Intake

The initial intake is when an individual can become the most violent or upset. The location in the non-secure area next to the vending machines could easily result in injuries to the arresting officer and the inmate while trying to secure the individual to the bench. The location in the non-secure area also subjects staff or public trying to access the administrative wing or vending to direct contact with the inmate. Any public in the area has direct view of who is being arrested and could become a privacy issue. The intake should be in the secure area of the facility.

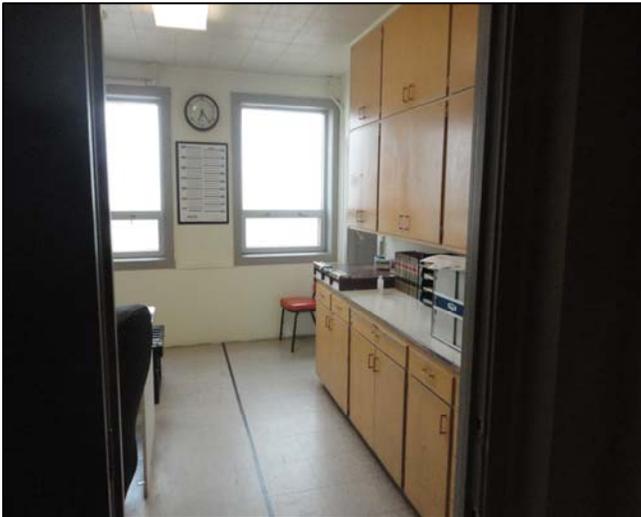
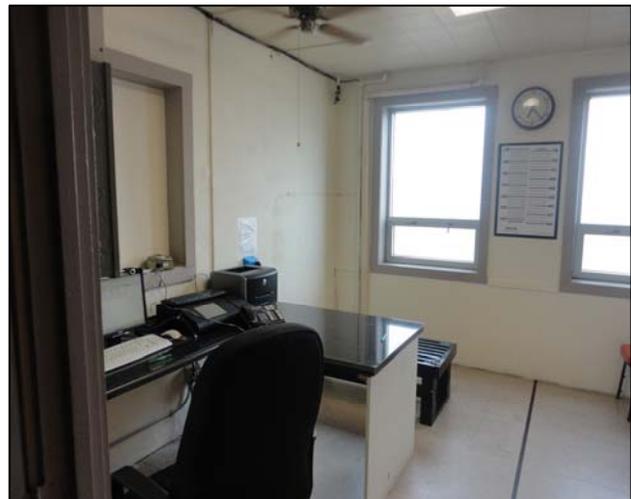
Booking

As identified in the Intake section, individuals are the most violent or upset when initially being processed into the facility. This area is located in the non-secure section of the building which has several exits that could allow for escapes. There are windows in this room that are accessible to the exterior of the building.

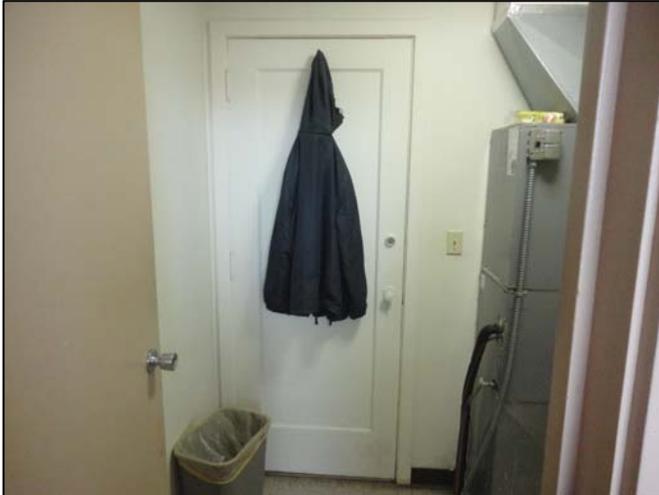
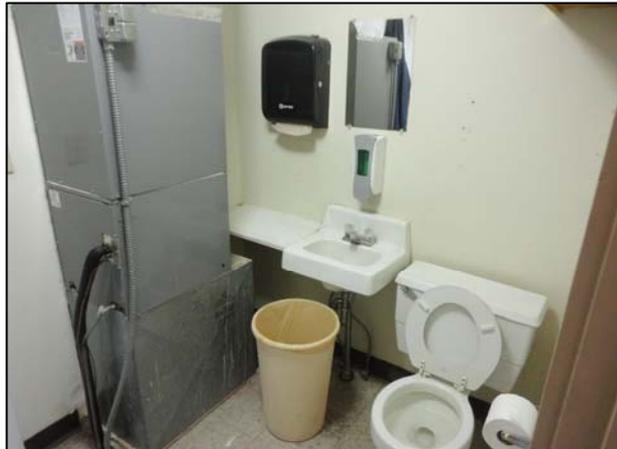
Search Area

The Search area has to be accessed through the food process area which could allow access to weapons that would be utilized for food processing. The current area consists of a residential type lavatory and toilet instead of penal type fixtures. The jail staff monitoring this procedure is out of sight of any other staff in case of an altercation. There is no shower available so a person would have to be taken into a jail cell block to shower prior to providing a uniform for change out. There is direct access into the secure jail housing area through a non-secure door.

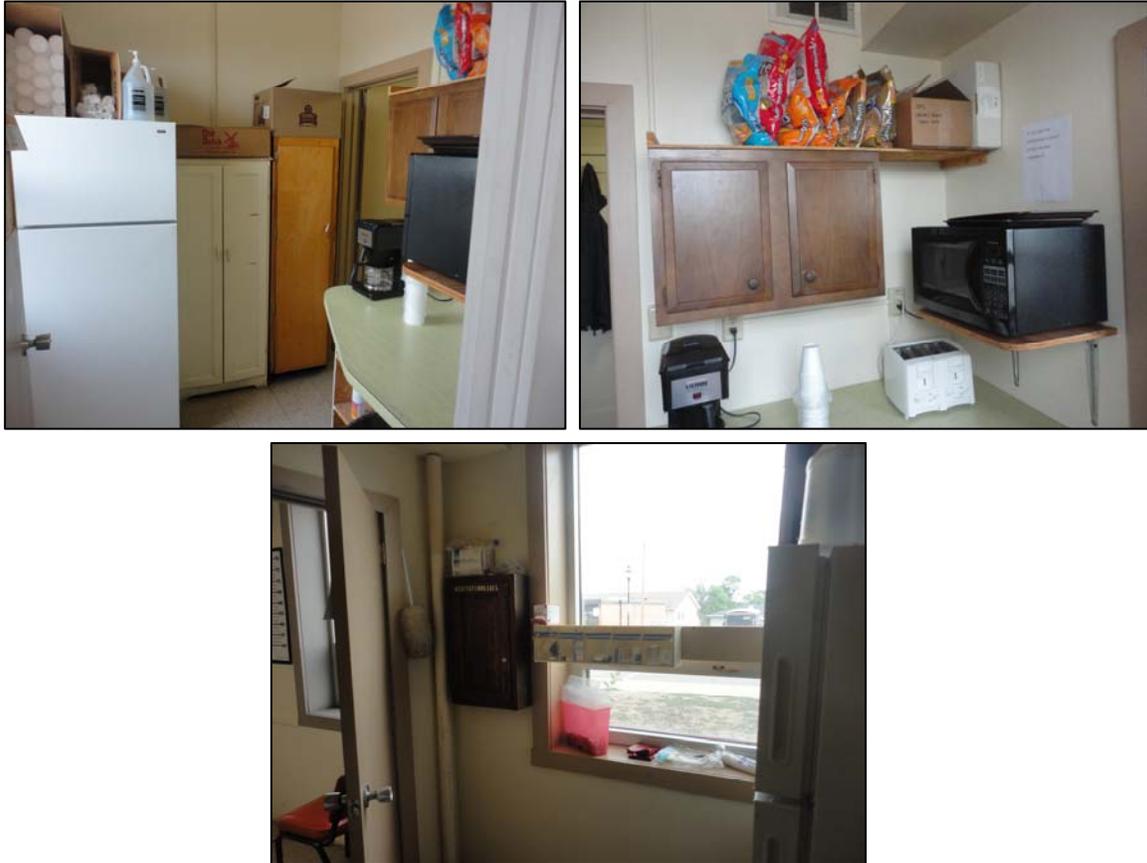
Food Service & Food Storage

The Search area is accessible only through the Food Service area from booking which means that individuals being processed are escorted directly through the area. This can create safety hazards with equipment and chemicals that could be possibly exposed as well as sanitation issues escorting these individuals to the Search area. There is also direct access to this room from an exterior window which could present security issues. There are additional privacy issues from any staff walking into process food or coffee for individuals being searched directly off of this room.

The cabinetry takes up most of the room and there is minimal storage available. Food is required to be stored on top of the cabinets and chemicals can't be secured. There is no sink in the food process counter and the only sink available would be the lavatory in Search. This is an unsanitary condition for cleaning dishes, sanitizing countertops and even hand sanitation for the staff.

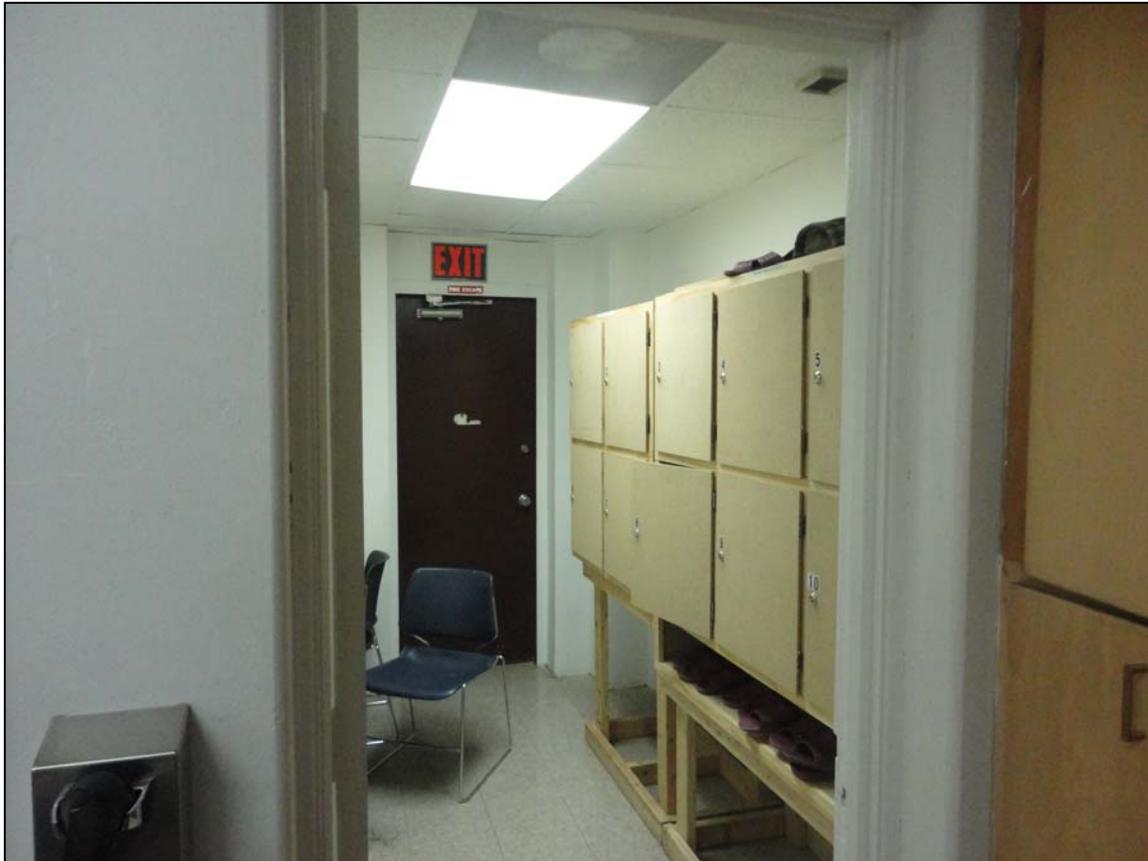
Inmate Property Storage

The lockable cabinets are sufficient for storage of the inmate property. However, allowing public into this area for visitation does create some security concerns. The door to this room would need to be closed for visitation purposes so the inmates could not see the visitors as well as the public could not view the inmates. The exit into the 1971 addition which is a non-secure section of the building could cause some security concerns. A hollow metal security door has been installed to minimize this risk.

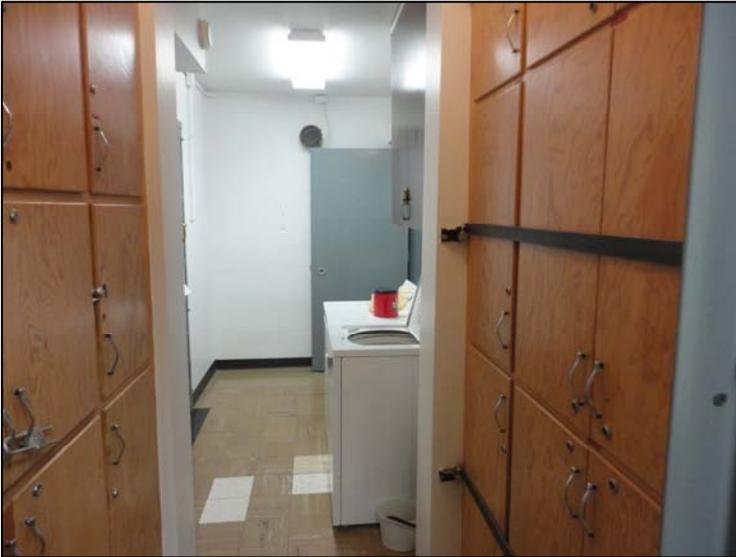
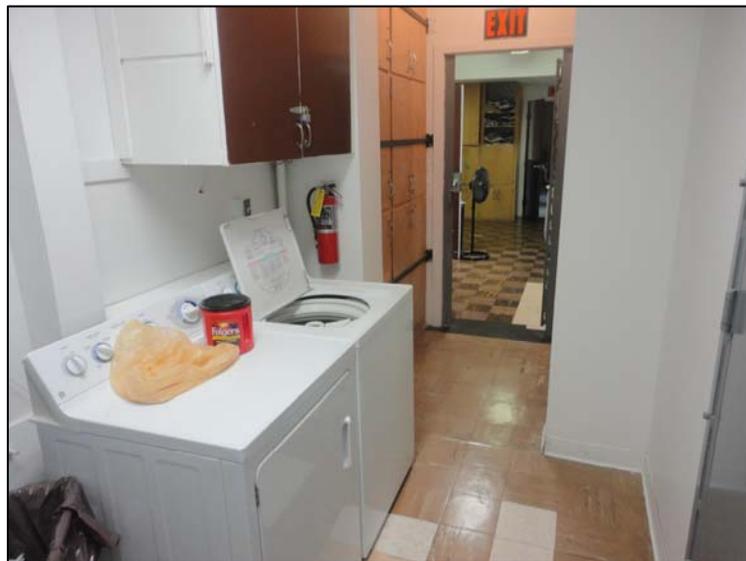
Inmate Issue and Laundry

The room is sufficient to meet the current needs for laundry and inmate uniform storage. However, the distance from the Search does create some staff inefficiencies. Staff would have to go into the secure section to get the uniform and return to the Search to have the individual dress out prior to entering the secure section of the jail.

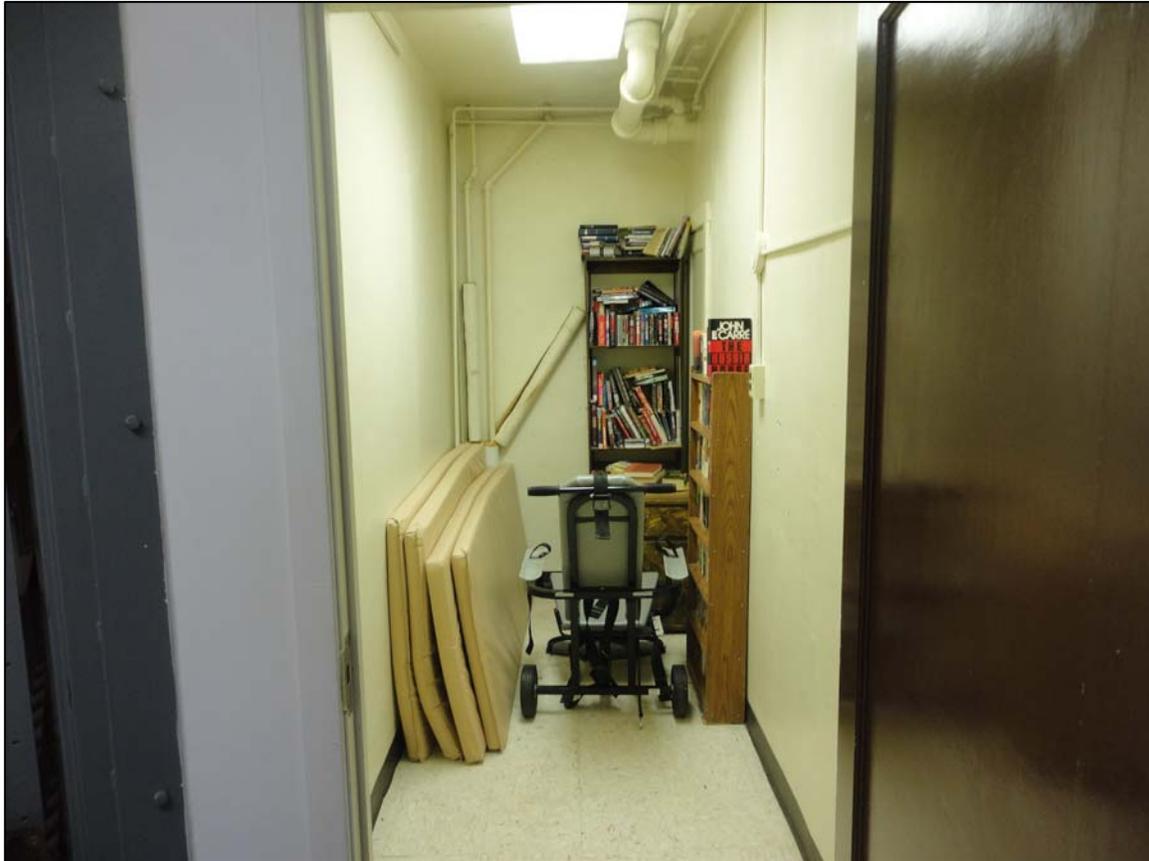
Jail Storage

This storage should be much larger to accommodate the materials needed to supply the Main Jail Housing area in lieu of storing the supplies in the corridor cabinets.

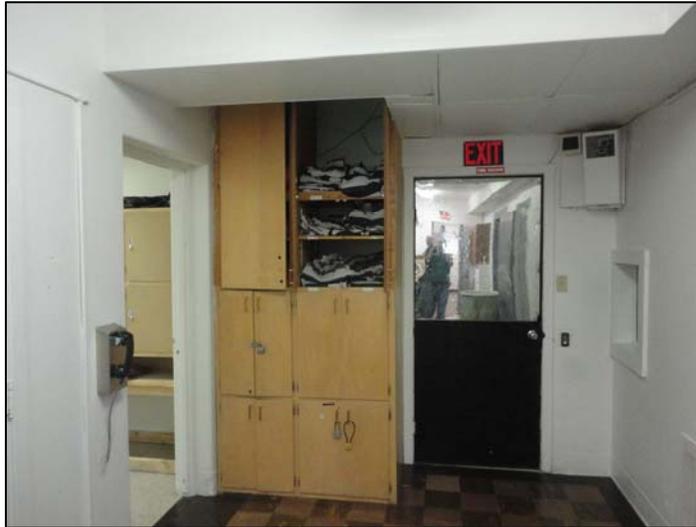
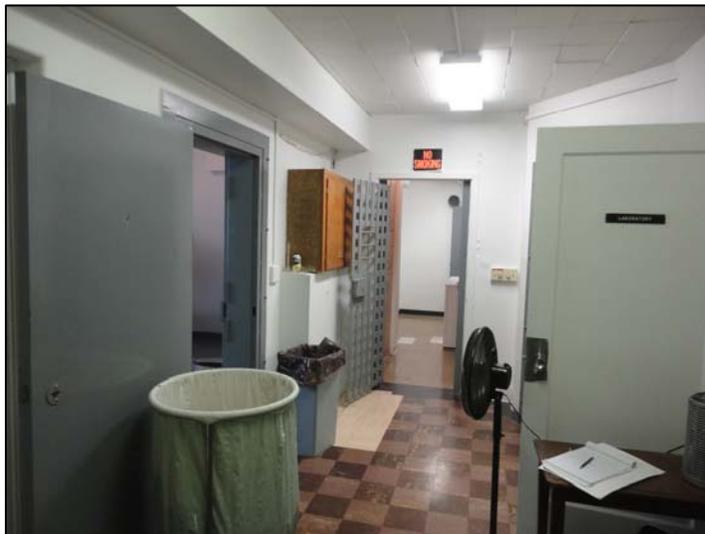
Main Jail Housing Corridor

The walls of the corridor are hardened construction which allows for minimal renovation to the Main Jail Housing area. The elevator shaft which is locked is also located off of the corridor. Soffits have been added to allow for modifications to provide heating and air conditioning and all electrical components have had to be surface mounted. Solid doors have been provided in addition to the cell bars to minimize sight lines from cell block to cell block as required by State Jail Standards. This does create additional work for the staff performing their hourly tours.

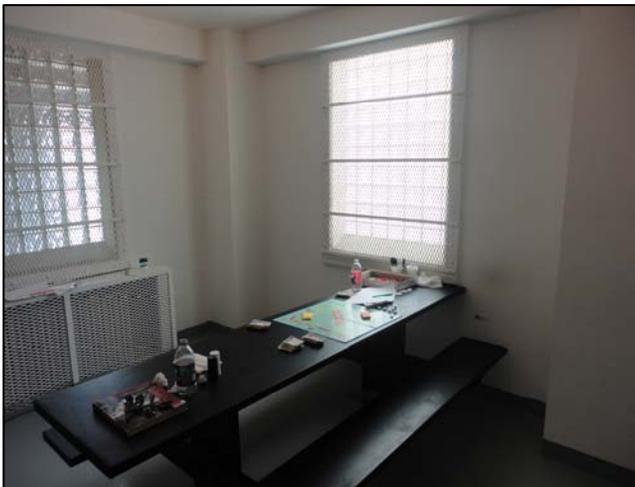
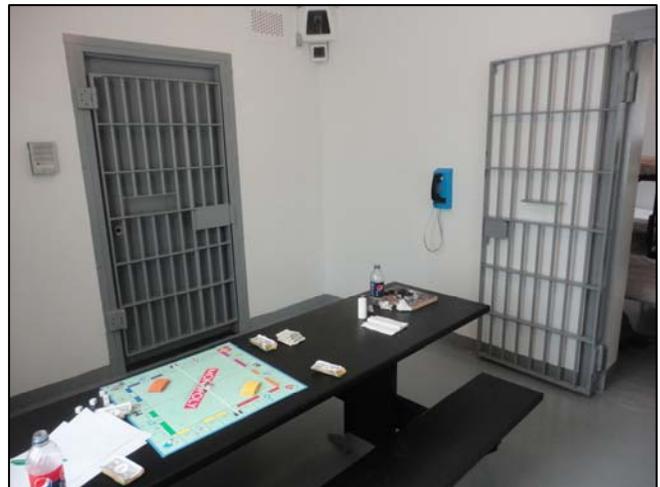
Male General Population Cell and Dayroom

The walls of the corridor are hardened construction which allows for minimal renovation to the Male General Population Cell block. The Female General Population Cell is directly across the corridor from the dayroom. This requires the solid door to be shut on one or both of the blocks to provide sight and sound separation as required by code. The layout does provide some blind spots for staff inspections which can present some safety issues. Steel grates have been placed over the exterior windows to provide some security. The cell bars, beds and other equipment offer potential hanging hazards.

The plumbing has been repaired consistently and will require replacement sometime in the near future.

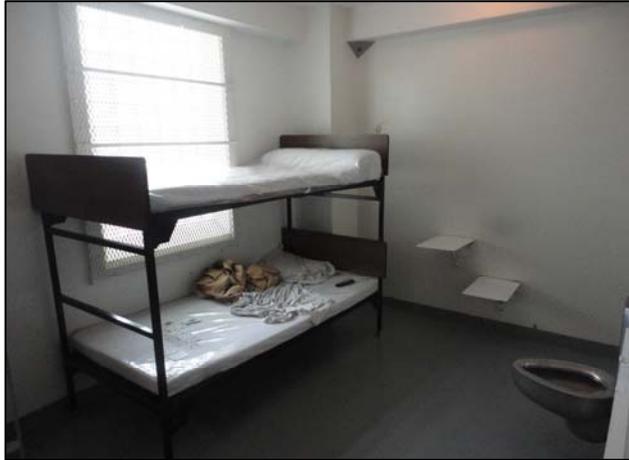
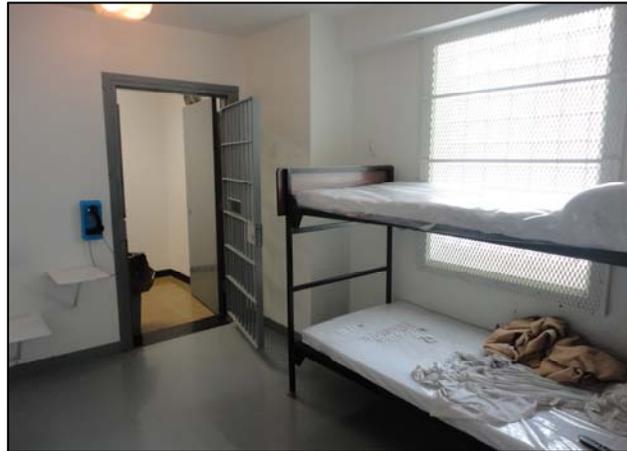
Female General Population Cell and Dayroom

The walls of the corridor are hardened construction which allows for minimal renovation to the Female General Population Cell block. The Female General Population Cell is directly across the corridor from the Male General Population Dayroom. This requires the solid door to be shut on one or both of the blocks to provide sight and sound separation as required by code. The layout does provide some blind spots for staff inspections which can present some safety issues. Steel grates have been placed over the exterior windows to provide some security. The cell bars, beds and other equipment offer potential hanging hazards.

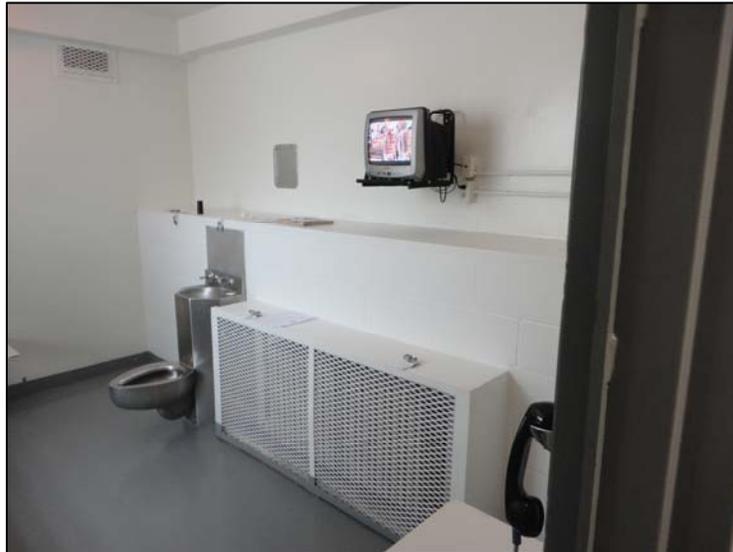
The heating is provided by radiant heat provided by radiators which have been enclosed in security grates. This type of heating is inefficient and

maintaining consistent temperatures is difficult and costly. The toilet is located in the sleeping quarters and offers no privacy.

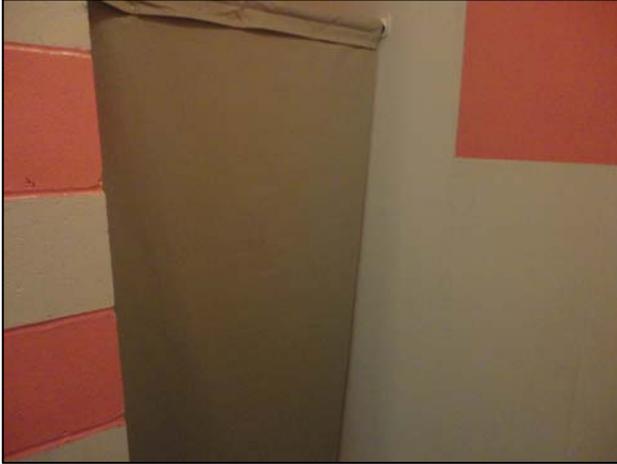
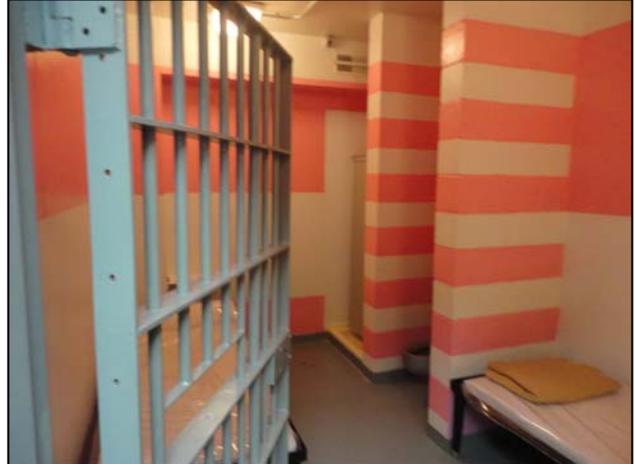
The walls of the corridor are hardened construction which allows for minimal renovation. The Detoxification Cell is directly across the corridor from the Male General Population sleeping quarters. This requires the solid door to be shut on the male block to provide sight and sound separation as required by code.

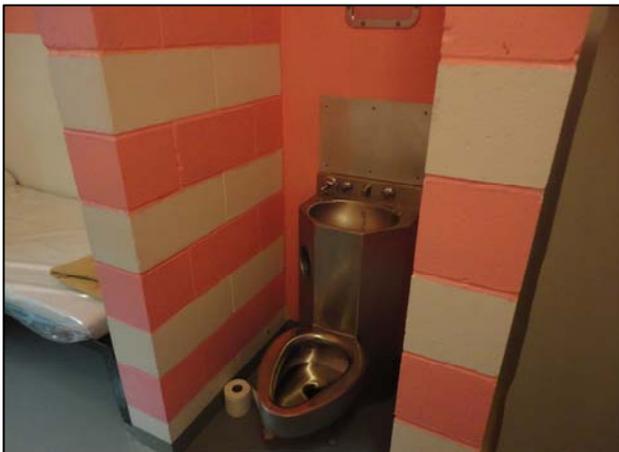
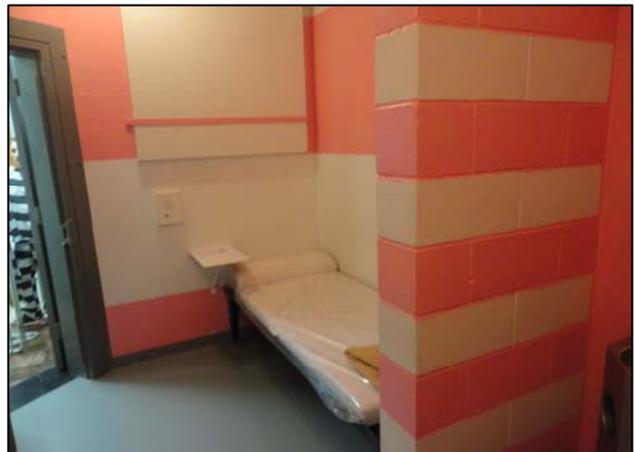
If this cell block is occupied, the person would have to be temporarily moved to allow the females to shower in this area and would require any inmates not classified as minimum security to be housed out of County.
